AN INVESTIGATION on TRADITIONAL TIMBER-FRAMED BUILDINGS in ÇANKIRI PROVINCE of TURKEY

Neşe DİKMEN (With contributions by Randolph LANGENBACH)

Anahtar Kelimeler: Timber-framed buildings, earthquake, traditional houses, Çankırı

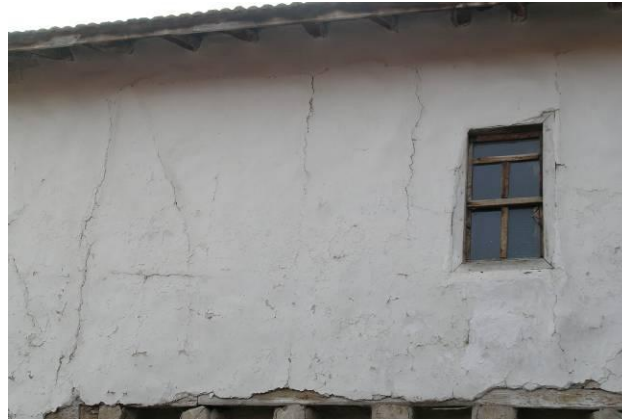
concrete structures, depending on where they are, may be indicative of much greater vulnerability to collapse than even larger cracks in traditional buildings (Langenbach, 2008b) (Figure 5). Although type of traditional timber buildings varies in different earthquake zones, according to Doğangün *et al.* (2005), their damages caused by earthquakes can be classified as follows:

Figure 5. Cracks in a timber-framed structure.

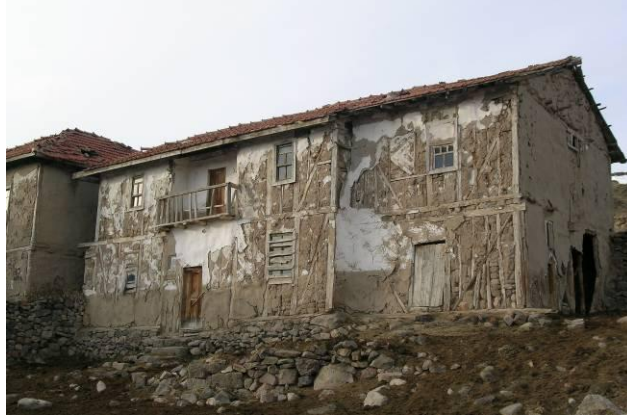
Survey conducted in the villages of Çankırı revealed that traditional construction system is timber frame with masonry infill in this region. In this system, which is called as “*yeğdane*” in the region, infill of the timber-frame is either sun-dried brick or natural stone. For instance, in Yuva Village, nearly all of the timber-frames have sun-dried brick infill, whereas in Ortabayındır Village natural stone infill is commonly used. The reason for that can be the abundance of stone in Ortabayındır village. It was observed that most of the timber-framed buildings in Yuva village had minimal or no damage. The exterior and interior plaster in the houses was cracked and often fallen off due to the earthquake (Figure 6, 7 and 16).

Figure 6. Timber-framed structure with sun-dried brick infill (Yuva Village).

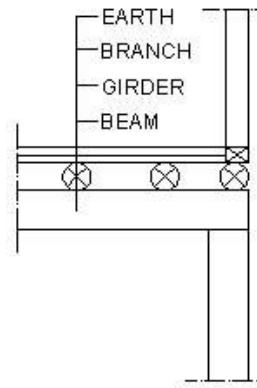
Figure 12 shows the flooring detail of the timber framed structures in Yuva village. The girders are covered with branches and the branches are covered with earth. In this type of structures although thickness of the earth is about 3 cm when a new house is first completed, it becomes thicker in time because earth needs to be maintained by adding new layers. This is a disadvantage from the point view of earthquake resistance of the structure because the building becomes heavier in time.

Figure 12. Flooring Detail

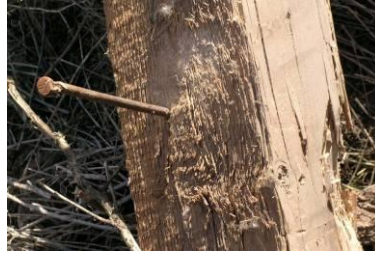
Nails are used to tie the timber elements to each other (Figure 13). The inhabitants of the region claim that nail was used consciously for construction of these buildings because it makes the structure more flexible. According to Sayıl (2001), use of nails and screws to tie the timber elements helps to absorb and as a result lower the movements created by earthquakes.

Figure 13. Nail used to tie the timber elements

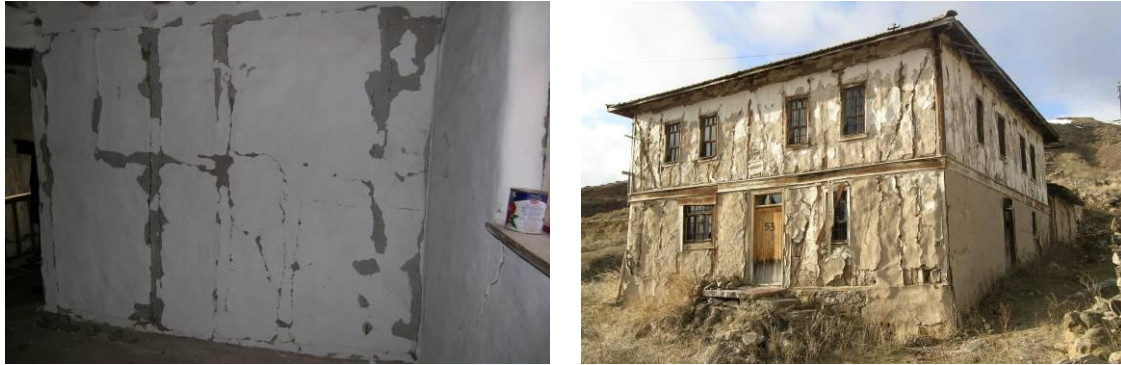
“I know that “yeğdane” does not collapse because of an earthquake. Interior and exterior plaster of my house fell down during the earthquake in 2000 and it was easy to repair it. I preferred to move to the post-disaster house since this house is made up brick and cement. It is easy to clean this house but difficult to use. When my children and grandchildren come to visit us they sleep in the living room, to which other rooms open, and we have to go through this space when we need to use WC” (Figure 16). (Female, 65, farmer)

Figure 16. Interior and exterior views of House 1

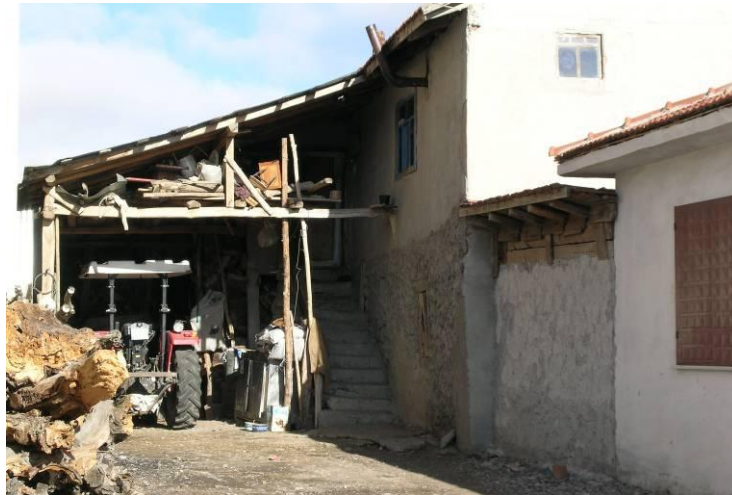
“One of the timber posts on the corner was damaged and the Government authorities recorded me as a post-disaster house beneficiary. I rejected to leave my house because it was easy to repair it. Government provided finance and engineers to repair my house. I am living with my wife, son and my son’s family in this house. We are a big family and I have animals. I knew that I would not be happy to live in the post-disaster house. Post-disaster houses are not appropriate for big families and also there is no cattle shed for the animals”. (Male, 72, farmer)

Figure 17. Repaired timber-framed building
