SEISMIC SOIL-STRUCTURE INTERACTION OF A MASONRY STRUCTURE: SUNGURBEY MOSQUE

Original scientific paper

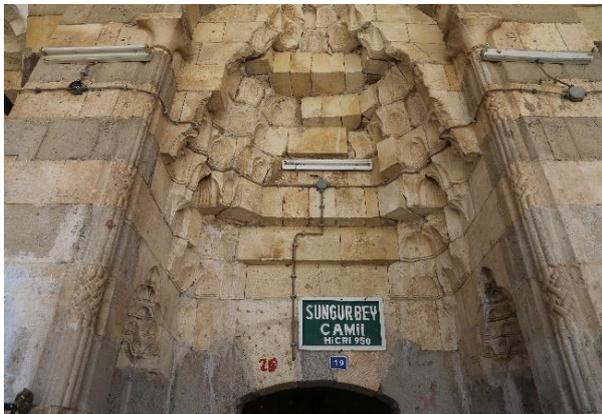
Assembly Problems: The decorations on the crown door of the mosque also showed defects in application and workmanship (Figure 3). In addition, some gaps were found in the joint fillings between the decorations. Especially as a result of the repetitive temperature changes of the settlement area, regional defects may occur in the decorations. In addition, significant manufacturing defects were detected at the stone joints in the interior (Figure 4).

Figure 3. Assembly problems of the crown door

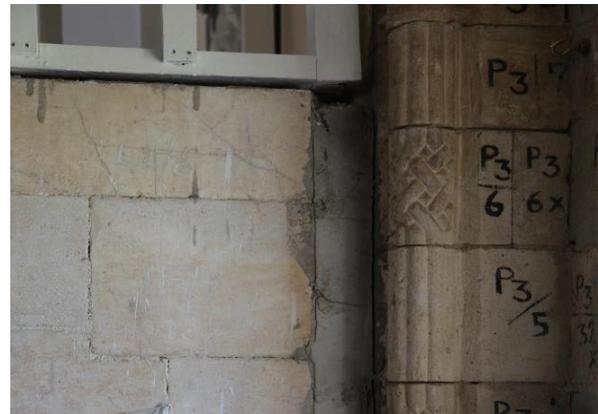
Figure 4. Stone wall joints problem in the interior.

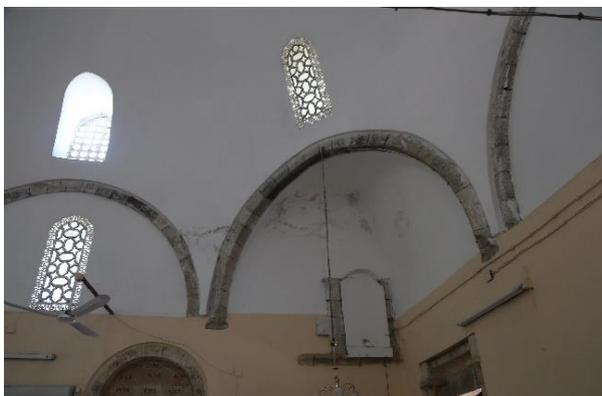
Figure 5. An example for Insulation problem.

part of the arch elements. In addition, insulation problems and plaster spills were detected in certain areas on the walls, under the windows and inside the dome (Figure 5). If preventive measures are not taken, this may lead to significant structural problems in the future. There are cracks in the lintel above the window that is suitable for capillary and development (Figure 6).

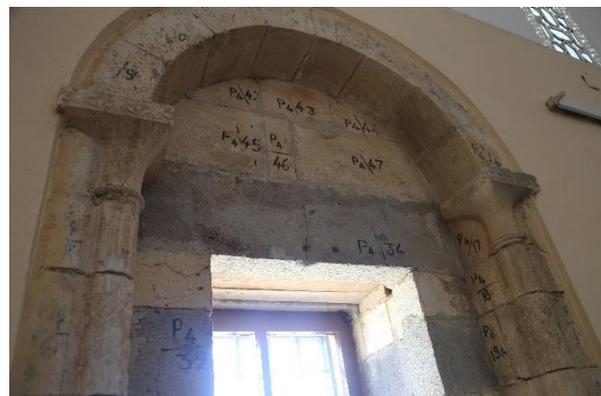
Figure 6. Cracks in the lintel above the window.

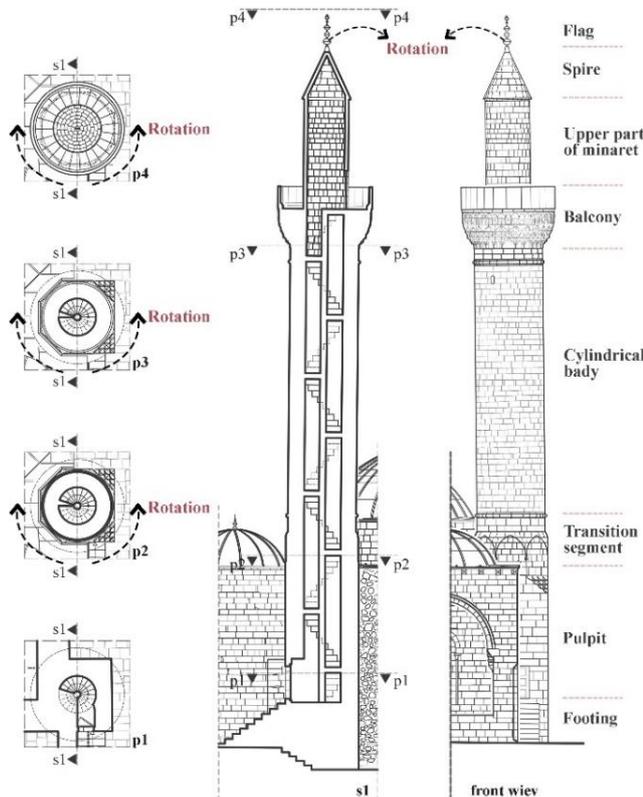
Significant deflections were detected on the basis of the single-story WC structures, which were built separately in the mosque yard. It is thought that this situation occurred as a result of differential settlements on the ground. In the body of the mosque minaret, a visible deviation from the vertical axis is observed at the exit level of the roof of the prayer hall. It is thought that this deviation will cause an important structural problem in the future. However, there is no clear information about whether this deviation occurred after the earthquake. (Figure 7).

Figure 7. Deviation observed in the minaret.

acceleration values increase as the considered nodal points get higher in terms of their elevation with respect to the base of the structure. The deflection observed on the minaret are attributed to the amplified accelerations along the cross-section.
