EVALUATION OF WEAR IN NEEDLES WORKING WITH OPEN END COTTON YARN

Sena CİMİLLİ DURU¹, Cevza CANDAN¹, Ata MUĞAN²

¹*Istanbul Technical University, Textile Technology and Design Faculty*

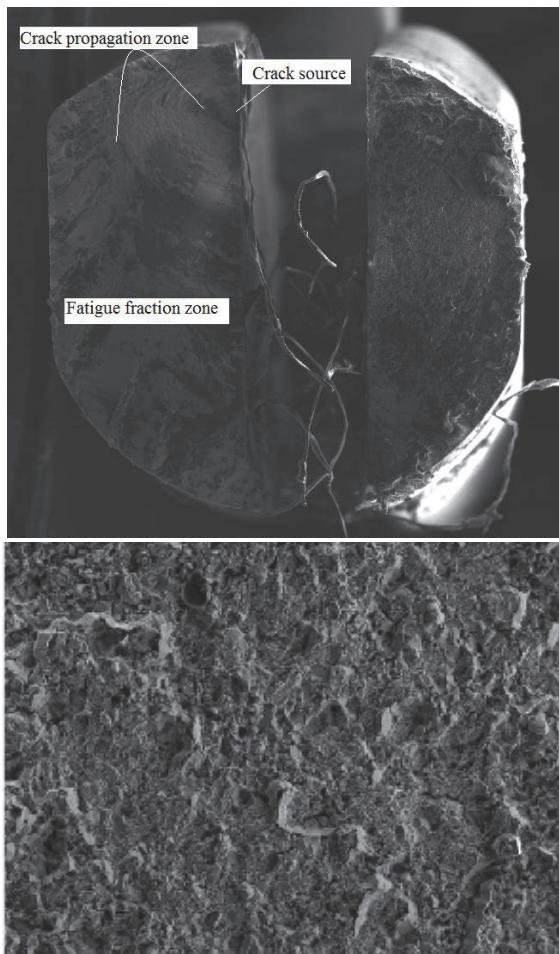
Figure 1. A-10x-Fracture needle rivet cross sectional view 13.492.242 courses B- 1000x-Enlarge image of dimples

The fracture is composed of three zones: crack source zone, crack propagation zone and fatigue fracture zone. Generally, the fatigue crack is prone to initiate at two kind of specific zones: 1- material surface and 2- inner defect of

material [11]. In our study there was only one fatigue source propagating from the surface as shown in Figure 1A. Heterogeneities, micro cracks and mechanical striations were observed when lateral surface of the unused needle rivet part was examined in detail under electron microscope. This could be an additional factor that had given rise to crack initiation as a result of stress concentration. The fracture surfaces of the particles are mostly perpendicular to the uniaxial loading direction, and the cracks propagate from the free boundary to inside, which is corresponding to a maximum principle stress direction. The cracks appear to propagate away from the nucleation site usually in a radial manner (see Figure 1A) [10, 12]. These striations represent the extension of the crack during the loading cycle. When the crack length increases to the critical crack length of the material, the material fractures instantly and meanwhile forms a rough surface since uncracked cross section of the needle could not carry the maximum load of the load cycle anymore. As a result, fracture surface is caused by the final failure in the last load cycle. Therefore, the final failure can be considered to be a quasistatic failure. The fracture zone consists of small quasi-cleavages planes, secondary fatigue cracks and dimples. Greater density of dimples can be observed on the fracture surface of the pivot as shown in Figure 1B.

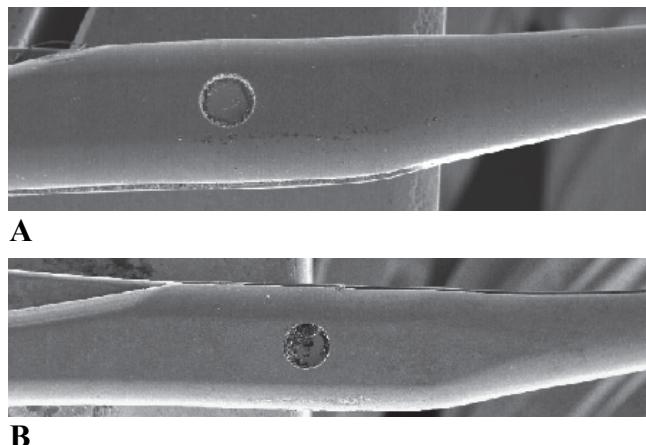
Figure 2A shows the rivet side view of an unused needle whereas Figure 2B presents the rivet side view of unfractured needle after 13.492.242 courses. From the SEM photos, it appears that wear of the latch hole and rivet had perpendicular visual sight to the latch stem. This finding corresponds with a study conducted by Groz-Beckert which suggested that most of the wear occurs when the needle is in its clearing position and the loop slides off the latch onto the needle shrank. As soon as the latch hole and rivet begins to wear, the loop (when it slides off the latch) is lifting the latch at the fulcrum point thus accelerates the wear of latch hole and rivet [2]. Also, this wear might be the result of abrasive particles in the open-end yarn etching the metal from the surface. As the yarn comes into contact with the throat area of the needle, these fiber particles which contain certain levels of micro dust generate wear on the latch blade and saw slot walls. This condition causes excessive latch play which accelerates wear on the latch spoon and hook tip.

Figure 2. A- 10x-Rivet side view 0 courses B-12x-Rivet side view 13.492.242 courses

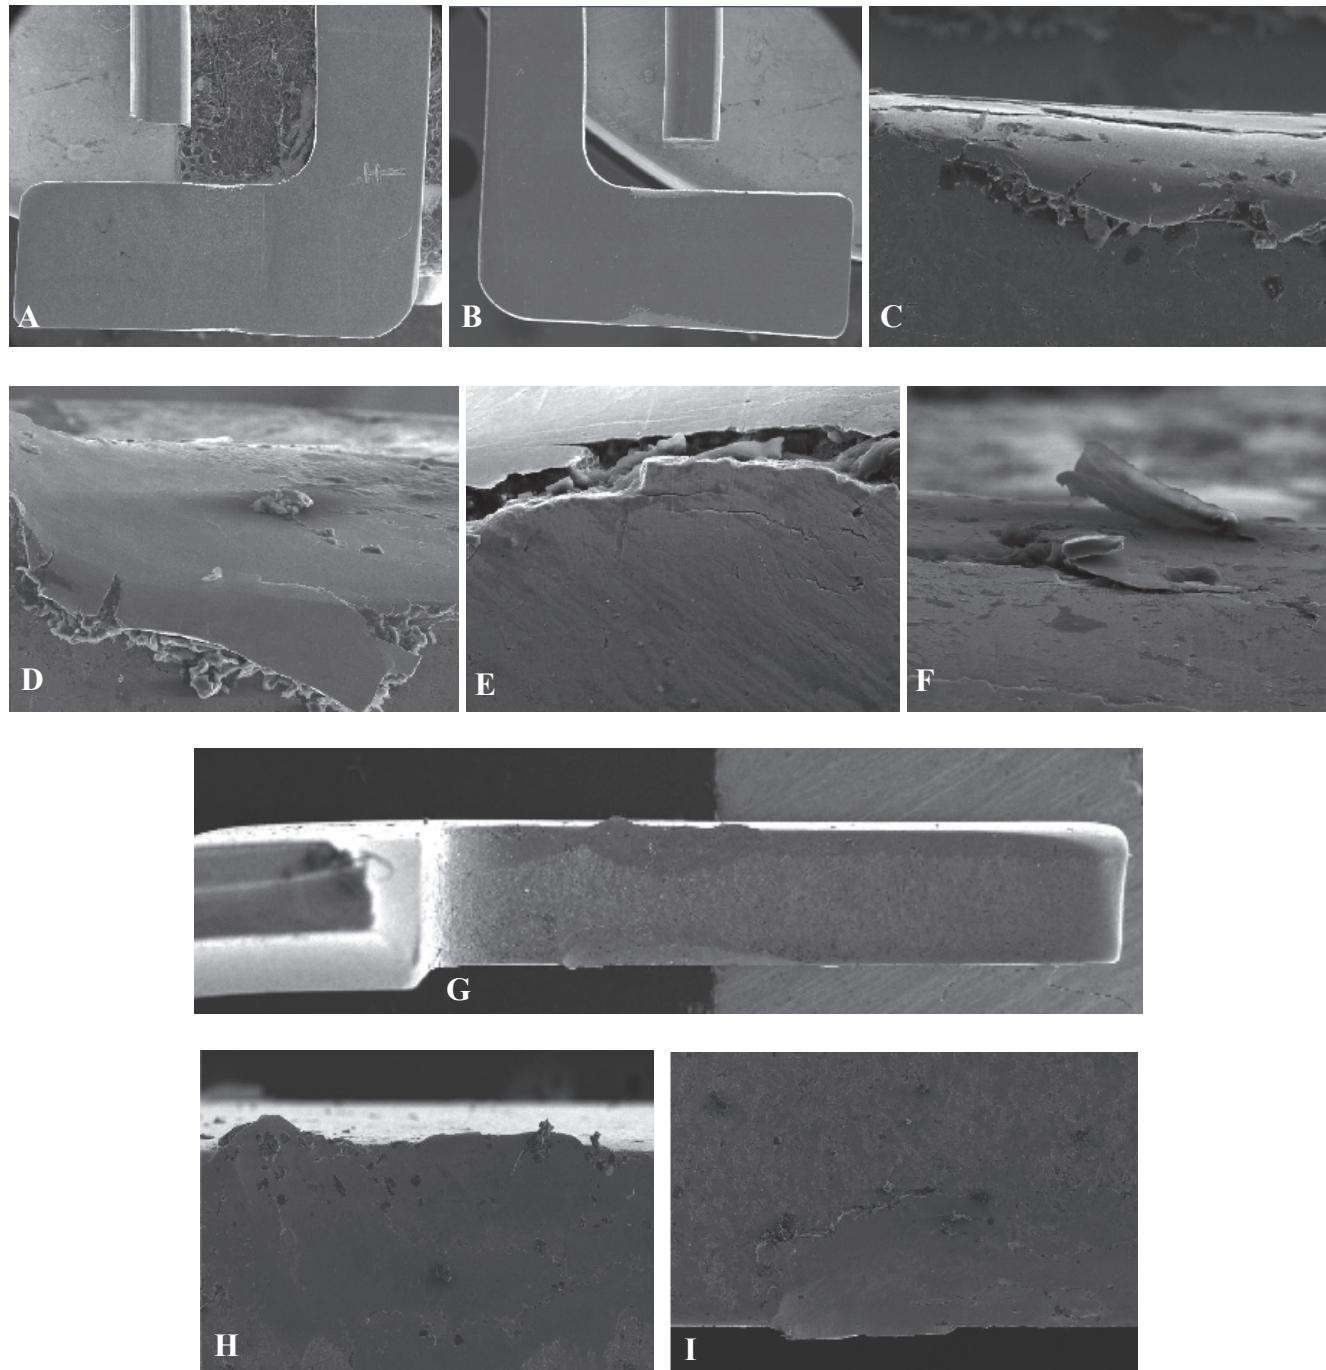
SEM photographs of used needles showed that there was a wear on both upper and bottom parts of the needle butt as seen from Figure 3. The wear mostly occurred in the areas where needle butt follows the cam path. Also, detailed SEM photos of the needle butt demonstrated that the wear at these points grew gradually when the total revolution of the needle was increased. Moreover, the amount of wear on each side of the needle butts was dependent on direction of the machine revolution as the right sides of the needle butts tended to wear more, when compared to the left sides.

Figure 3. A- 10X- Left side view 13.492.242 courses B-10X-Right side view 13.492.242 courses C- 250X-Left side view 13.492.242 courses D-250 X- Right side view 13.492.242 courses E-1000X- Left side view 13.492.242 courses F-1000x- Right side view 13.492.242 courses G-10 X-Overhead view 13.492.242 courses H-100X-Left overhead view 13.492.242 courses I-100X-Right over head view 13.492.242 courses

The major cause of accelerated needle wear on the needle butt, when using open-end yarns, was the high number of contaminants and small fibers in the yarn which filled into the needle path and slots. Hence, this increased the contact surface and friction between cam and needle which in turn increased the needle wear.

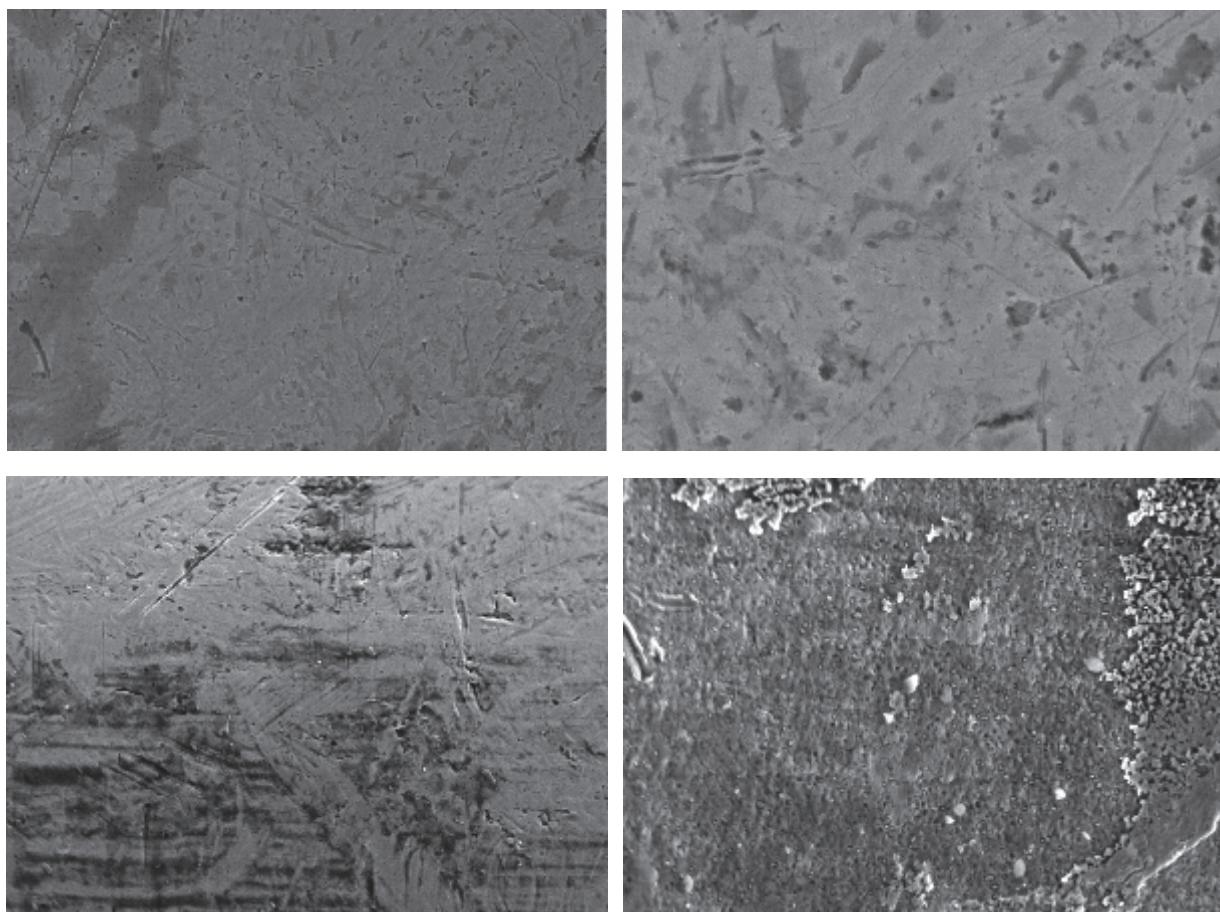
Three unused needles had been examined on the scanning electron microscope (see Figure 4). Two lowest magnifications illustrated that there was some differences in surface features between different unused needles. However, all of them had rough surfaces, defects and cavities at inner contour and two sides of the hook. And, although two sides of the needle hook had different visual view like the different needles surface varied visual characteristics, both sides had similar defects and cavities.

Figure 4. Unused needle hook view A-1000X- Left side view 0 courses B-3000X- Left side view 0 courses C- 3000x- Hook inner contour view 0 course D-3000x- Hook inner contour view 0 courses

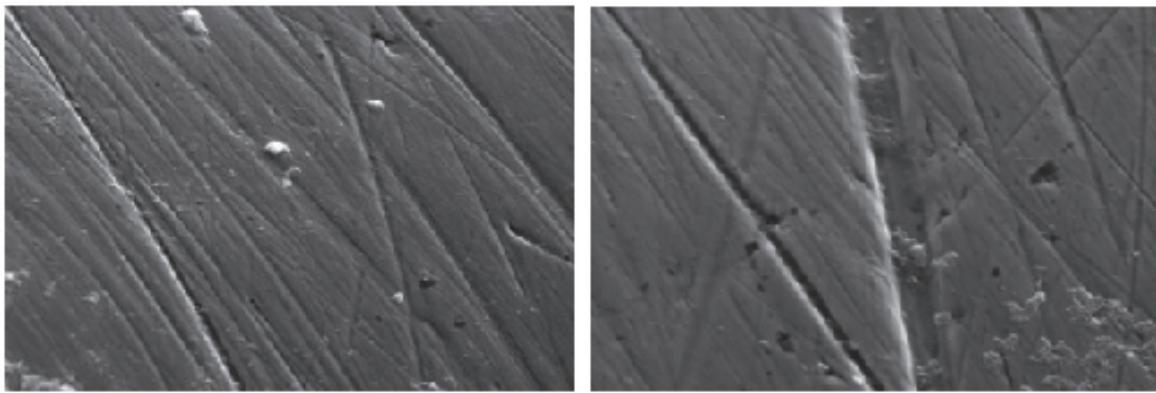
part moved in more by increasing the number of knitting courses especially at inner contour of the hook. Furthermore, the grooves occurred due to the heavy yarn friction between the yarn and the needle hook became more deepened and extended as the number of knitted courses increased. Figure 5 shows the detectable wear on the inner contour of the hooks at needle breakage time for two different magnification levels. Moreover, abrasive wear was observed on the side of the needle hook as the number of knitted courses was increased. When the needle go through the cam path with a back and forth motion, needle butt creates alternating sign impacts at the moment of the change in the direction of motion which results in collision between latch and hook, hook and thread guide. By doing so, this causes failure of the hook fatigue in nature. In addition to that, uncontrolled and entangled nature of the fibers of the open-end yarn structure played a prominent role in wearing of the hook structure. It is believed that contaminants which are carried out with the yarn from open-end were largely responsible for this increased wear because their relative hardness was higher than the needle itself.

Figure 5: A- 2000x–Hook inner contour view 13.492.242 courses B- 3000x - Hook inner contour view 13.492.242 courses

The comparative study of SEM photos of both groups of needles (used & unused) taken at high magnification, the surfaces of the tops and sides of the grooves were remarkably smooth. Because when two surfaces are in contact, their real area of contact is much less than their apparent area of contact, since it is confined to a number of small areas where opposing high spots touch. Hence, the pressure in these regions was high and the material was overstressed or deformed by the applied load until the contact area was sufficient to support the load. Groove formation cannot be due merely to displacement or removal of asperities. It would seem likely that, in addition to the removal of metal from the surface, there was some plastic deformation of the metal, possibly involving the filling-in of craters [13].
