The 2009 L'Aquila earthquake (Italy): Its characteristics and implications for earthquake science and earthquake engineering

¹Ömer AYDAN, ²Halil KUMSAR, ³Selçuk TOPRAK

1Tokai University, Department of Marine Civil Engineering, Shizuoka, JAPAN ²Pamukkale University, Department of Geological Engineering, Denizli, TURKEY ³Pamukkale University, Department of Civil Engineering, Denizli, TURKEY

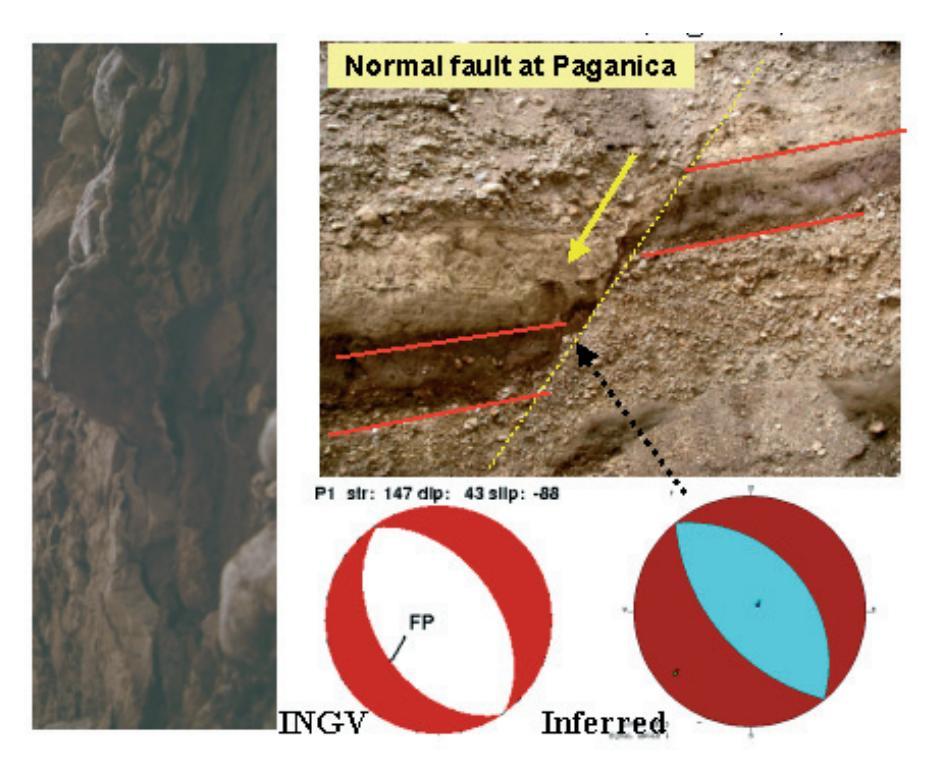
method. It was particularly interesting to note that the parameters of the active fault observed at Paganica were almost the same as those of the focal plane solutions estimated by several seismological institutes.

Figure 4. A very young fault in Paganica and comparison of inferred focal mechanism. Şekil 4. Paganica'daki çok genç bir fay ve odak mekanizmasının karşılaştırılması.

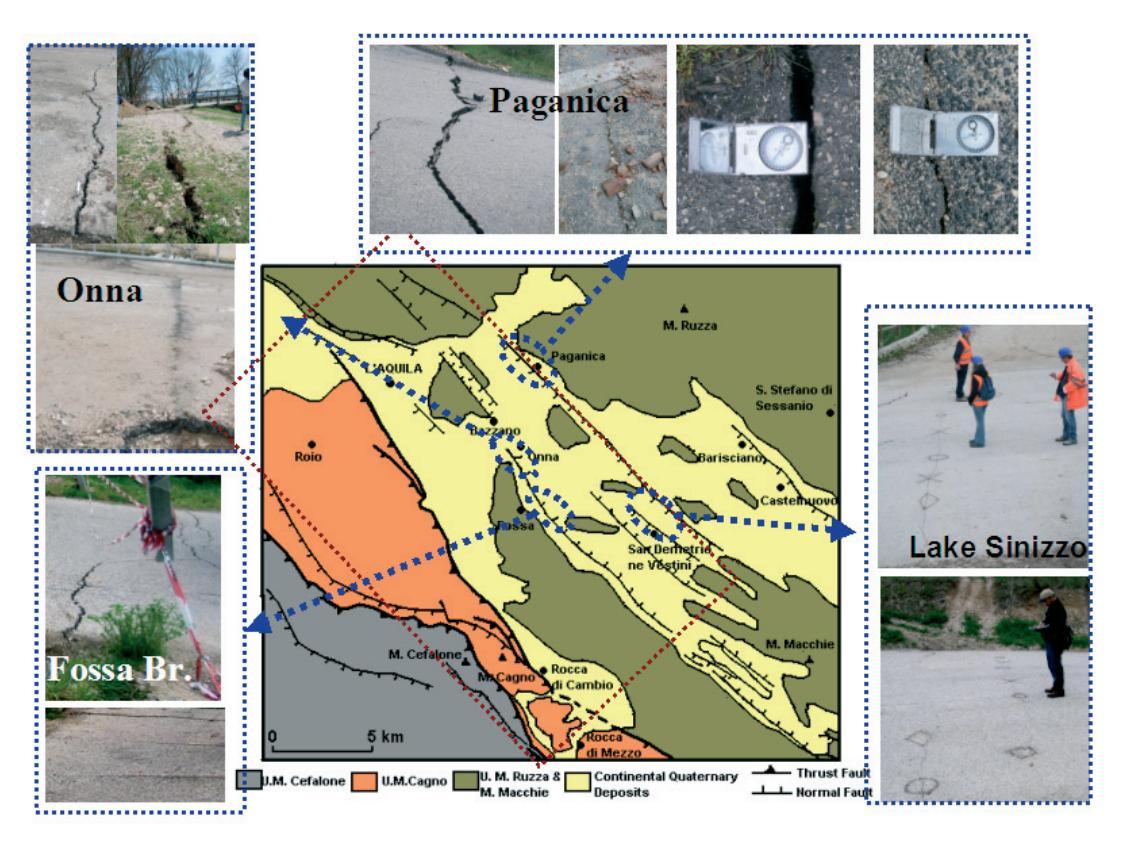
Surface ruptures were observed during the reconnaissance at the localities of Paganica, Lake Sinizzo, Onna and Fossa Bridge (Figure 5). Surface ruptures were also observed at three locations in Paganica town. Most fractures in Paganica indicated the opening of surface cracks with a normal displacement.

The authors observed cracks on the road to Lake Sinizzo, which is thought to be the southeastern end of the earthquake fault. There were also surface cracks in the vicinity of damaged or collapsed bridges on the Aterno River near Onna and Fossa.villages Some of the cracks were of a compressive type while most of them were of an extension type. As the permanent ground displacement inferred from the InSAR technique (INGV, 2009) concentrates along the Aterno River, the surface ruptures seen in these localities may also imply the extension of the L'Aquila basin in a NE-SW direction, (this is a graben structure) and that the Aterno River flows along a course at the lowest elevation of the basin. The INGV (2009) geological group also reported that surface fractures occurring at Paganica extended to the north of the A24 Motorway, which may imply that some surface ruptures might pass beneath the via-

Figure 5. Locations and pictures of surface ruptures. Şekil 5. Yüzey kırıklarının yerleri ve görüntüleri.

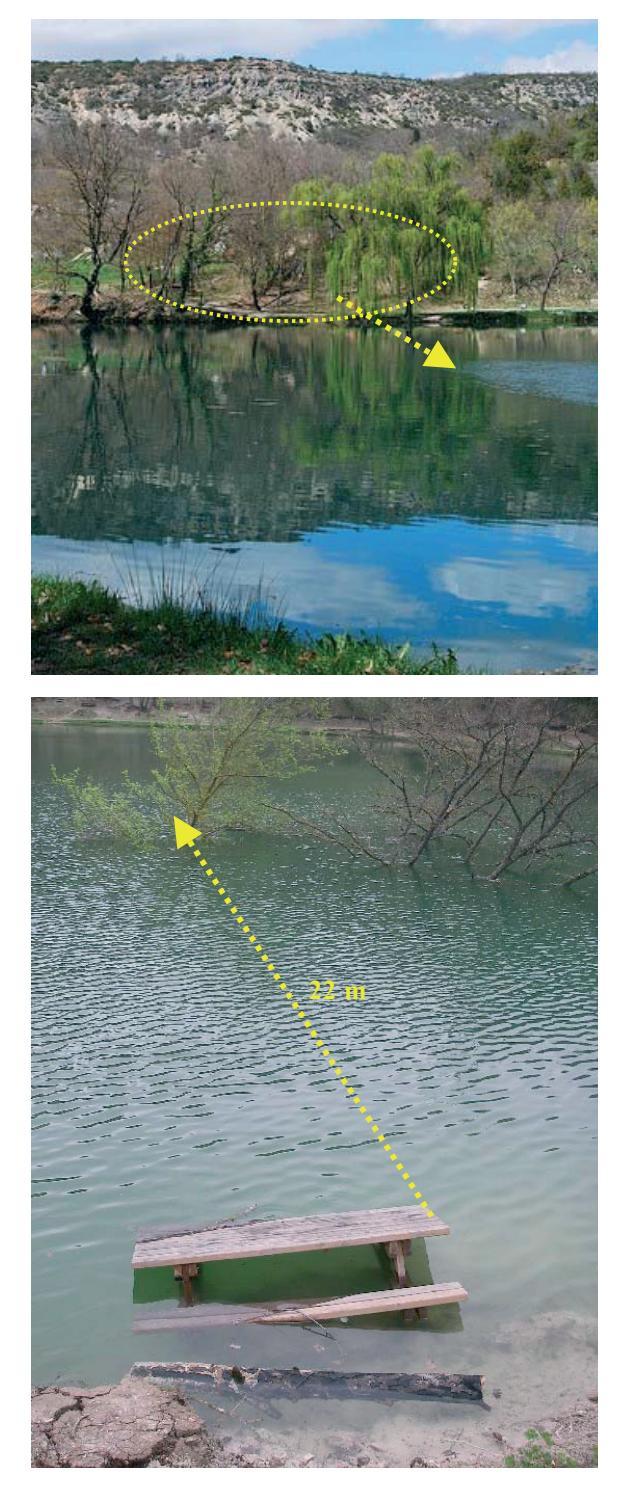
The Abruzzi region is karstic and many sinkholes and dolines exist in the epicentral area. Lake Sinizzo is a doline lake with embankment reinforcement on its northwest side. The lake is 9.8 m deep and it has an average diameter of 122.7 m (Bertini et al., 1989). Extensive ground failures took place around the shore of Lake Sinizzo (Figure 12). Although the surrounding ground is mainly calcareous conglomerate, the lakebed is composed of Holocene deposits.

Figure 12. Views of the ground failure before and after the earthquake.

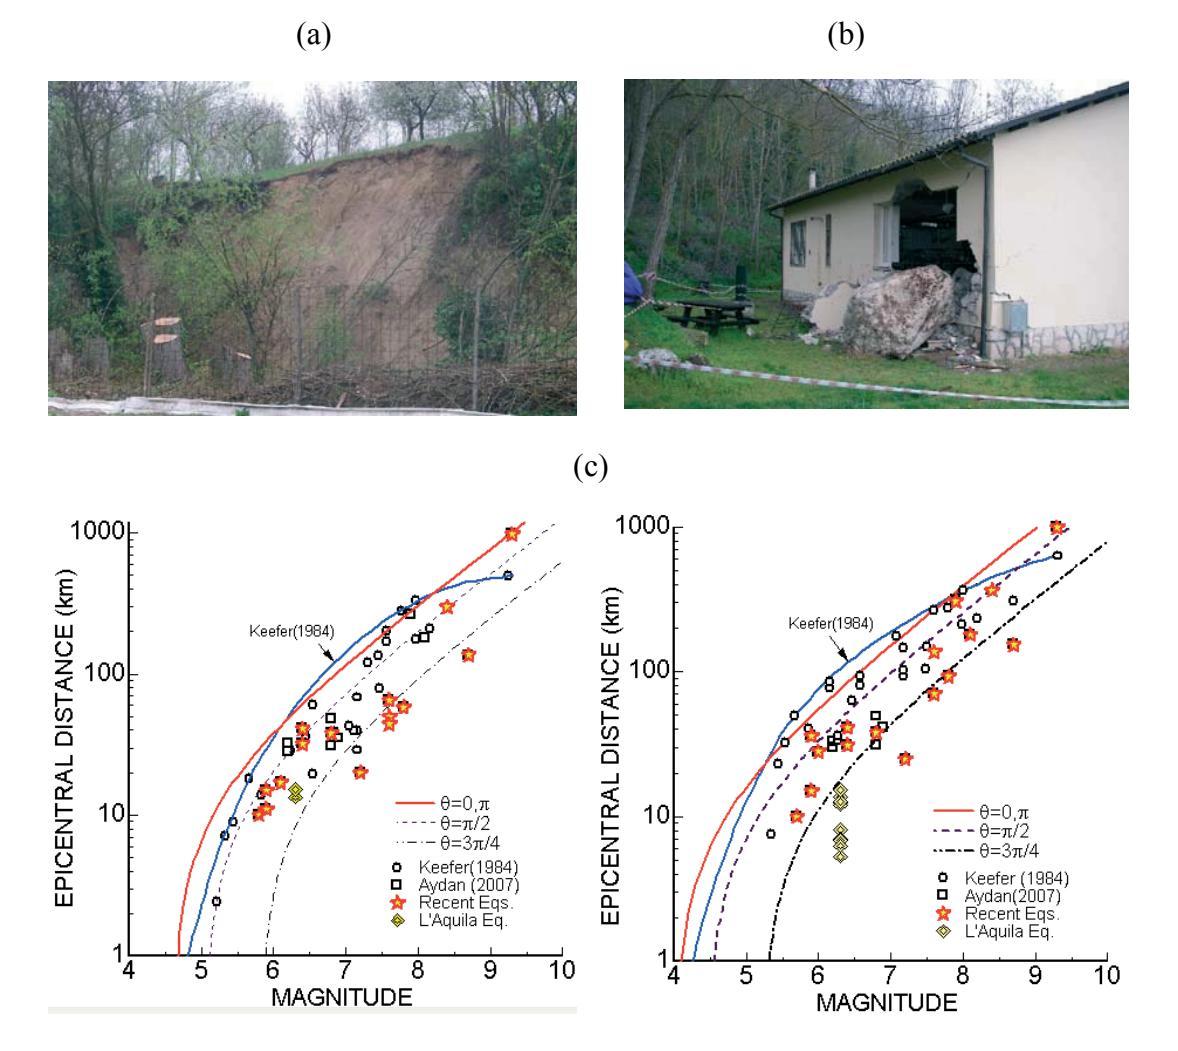
ved along the Aterno River's shores in mountainous areas such as in the vicinity of Campotosto. Figure 13a shows a soil slope failure along the Aterno River in the Martini District.

Rockfalls were observed in the areas where steep rock slopes and cliffs outcrop. Large scale rock falls were observed in the vicinity of Stiffe, San Demetrio and Lake Sinizzo, and Paganica (Figure 13b). Some of these rockfalls induced damage to structures. Nevertheless, the rock-

Figure 13. (a) Soil slope failure at Martini district, (b) rockfall at Stiffe, and (c) comparison of data of L'Aquila earthquake with empirical bounds (coherent slopes and disturbed slopes).

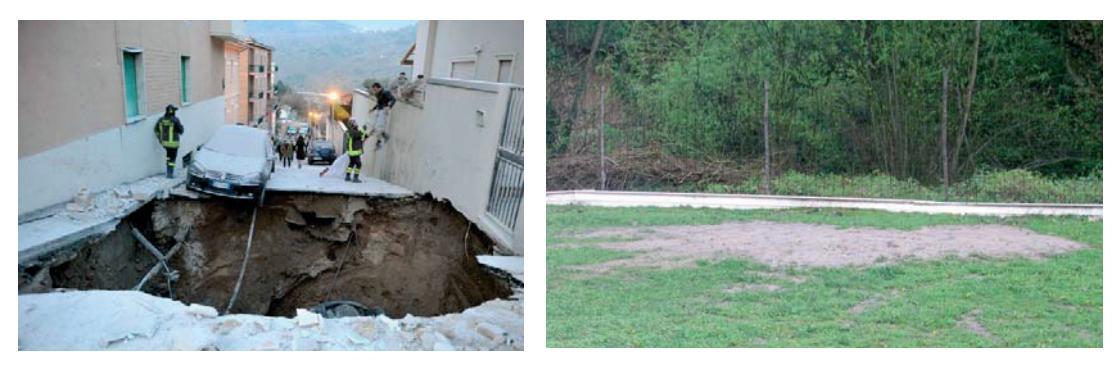
Figure 15. (a) A sinkhole in L'Aquila, and (b) liquefaction in Martini district. Şekil 15. (a) L'Aquila'da karstik bir çökme ve (b) Martini bölgesinde sıvılaşma.

kely to have resulted in the locations of the meanders. In the Martini district, liquefaction created many NE-SW trending fractures parallel to the river embankment, as shown in Figure 15b. Sand boiling as thick as 150 mm was observed in various locations. The movement of ground was towards a SE direction. Boiled sand is almost homogenous and its grain size distribution falls within the easily-liquefiable bounds according to the classification issued by the Port and Harbour Research Institute of Japan (1997).

The ground liquefaction also induced lateral spreading. The sum of crack openings from the adjacent field towards the river embankment ranged between 250-350 mm. There were several depot-like structures and bridges for railways and roadways in the area where soil liquefaction was observed. However, there was no visible damage to the structures, probably because the foundations were resting on deep stiff soils.

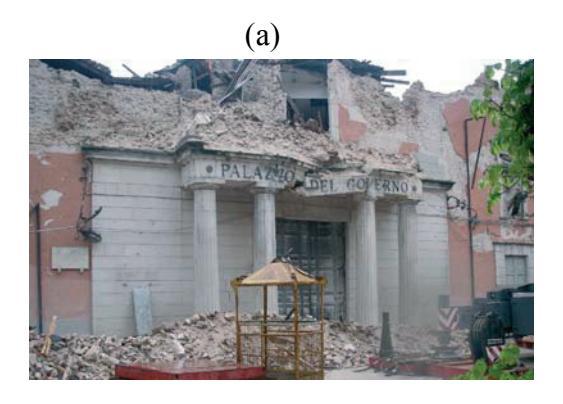
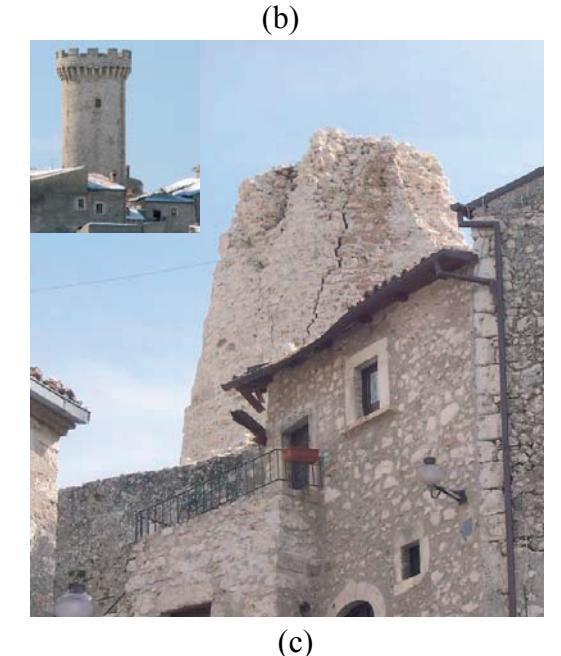
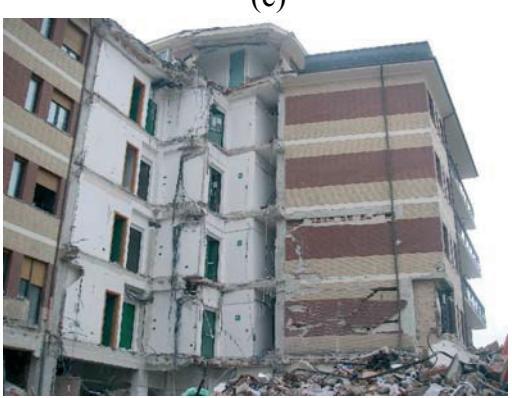
Masonry buildings can be grouped into two; specifically, residential buildings and cultural and historical masonry buildings (Figure 17a). Residential masonry buildings are generally two story buildings and in this area they were made of stone or brick, or a mixture of stone and brick. The mortar is mud or lime. Heavily damaged or collapsed buildings had almost no tie beams. Furthermore, the mortar of these buildings was mud. The main cause of the collapse or heavy damage to masonary buildings was out-of plane failure.

Cultural and historical buildings are of a larger scale and involve domes, towers and facades. The failure mechanism of these buildings is fundamentally quite similar to that of ordinary masonry buildings. The non-existence of tie beams make these buildings guite vulnerable to heavy damage or collapse. The dome of Santa Maria del Suffragio collapsed although wooden tie beams had been used. As the wooden tie beams were not continuous over the perimetry of the dome, the effect of the earthquake was disastrous. The masonary cylindrical tower at Stefano di Sessanio, which is about 20 km from the epicenter, had completely collapsed (Figure 17b). It was important to notice that another tower of almost same height and located at the foot of the same hill survived the earthquake. This may be related to a difference in the amplification characteristics of the top and the foot of the hill, as well as to the shape and shaking characteristics of the towers.

- Figure 17. (a) An example of masonry building damage, (b) views of the tower of Stefano di Sessanio before and after the earthquake, and (c) an example of heavily damaged or collapsed reinforced concrete building.
- Şekil 17. (a) Yığma yapılardaki hasara bir örnek, (b) Stefano di Sessanio kulesinin depremden önceki ve sonraki görüntüleri ve (c) ağır hasara maruz kalmış betonarme bir yapıya örnek.

Many reinforced concrete (RC) buildings had either collapsed or were heavily damage by the earthquake (Figure 17c). The reasons for the heavy damage or collapse are similar to those found in Turkey (Aydan et al., 2000a, 2000b) and elsewhere. The possible reasons are poor workmanship, design and construction mistakes, resonance, lack of professional ethics, the soft floor effect and collision. It was interesting to note, in some of heavily damaged buildings, that unwashed sea sand had been used for concrete mixture even though this place is 90 km away from the sea.

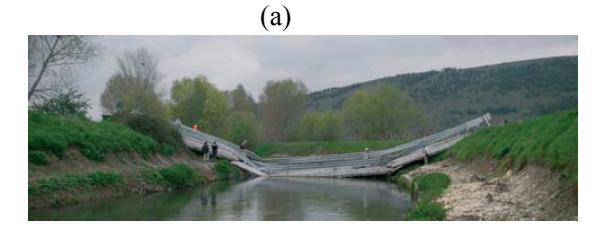
A 35 m long and 5 m wide, three-span, continuous reinforced concrete bridge had collapsed, as seen in Figure 18a. It was located at the crossing of SR261 to Fossa on the Aterno River. Four reinforced concrete columns with hexagonal sections had been broken at their column-slab connections, and had slid sideways and penetrated the deck slab. The columns had six 17 mm diameter smooth bars at each corner of the hexagonal section. 9 mm diameter smooth bars had also been used to fix the top of the columns to the reinforced concrete girders. The stir-ups were 6 mm in diameter at a spacing of 300 mm. The vertical downward motion might have played an important role in the failure of this bridge.

Figure 18. (a) A collapsed bridge, and (b) damage to A24 expressway. Şekil 18. (a) Çökmüş bir köprü ve (b) A24 otoyolunda hasar.

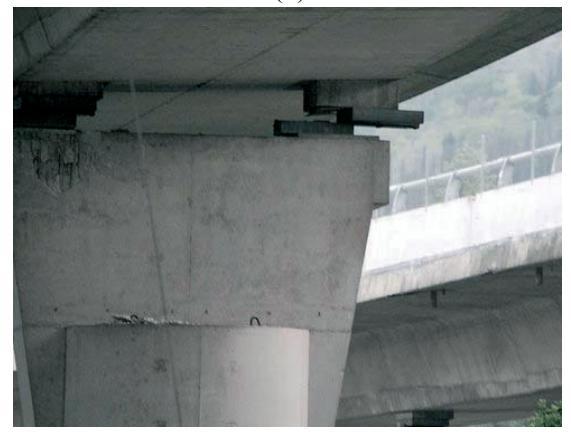
(b)

A part of the viaducts of the A24 expressway near L'Aquila was affected by the earthquake, although the expressway itself did not collapse

anywhere (Figure 18b). The viaducts are simply supported PC box-girder bridges supported by reinforced concrete piers. They were supported by steel sliders and roller bearings or elastomeric bearings. The viaduct was displaced and there were gaps as large as 200 mm at numerous locations. A number of decks had drifted in the longitudinal and transverse directions. Some of these gaps were repaired by asphalt filling.

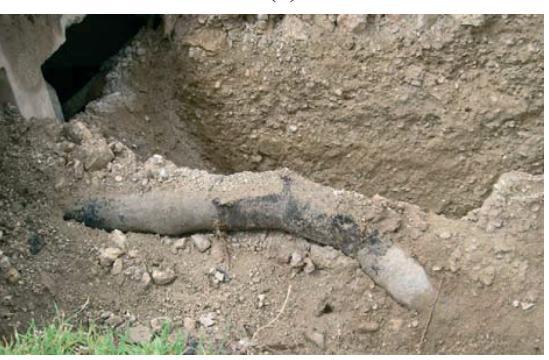
- Figure 19. (a) A pipe damaged by permanent ground movement near Onna, and (b) view of a buckled silo.
- Şekil 19. (a) Onna yakınlarında kalıcı yer deformasyonu nedeniyle hasar görmüş bir boru ve (b) bükülmüş bir silodan görünüm.

induced lateral spreading. The authors observed damage to water pipes in Paganica and near Onna. (Figure 19a). The damage to water pipes in Paganica was caused by the combined effects of faulting and slope failure. Pipes were damaged due to the extensional movement of the surrounding medium. The damage to a pipe near Onna was caused by the movement of its surrounding ground towards the center of the bridge over the Aterno. The pipe was damaged on both sides of the river. Nevertheless, the movement was much larger on the eastern side of the bridge where the pipe was buckled.

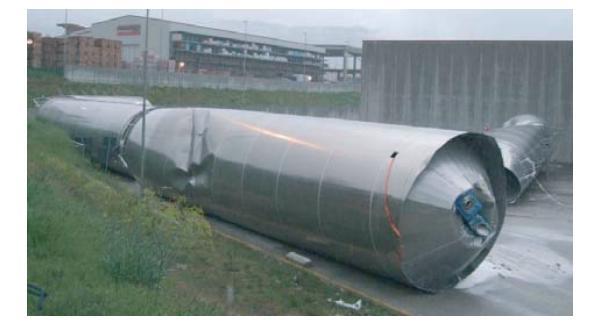
There are many industrial facilities in the area affected by the earthquake, but there was almost no damage to pre-cast industrial facility structures, which are generally vulnerable to earthquakes. The good design and construction of the beam-column joints of these pre-cast facility structures could be the main reason for their good performance and resulting undamaged state. However, 20 m high and 4 m diameter silos for storing polypropylene pellets in the VIBAC plant suffered from a severe buckling problem, as seen in Figure 19b.

There were two types of silos built at different times. The first one was a group of 8 silos founded on a common pile foundation and supported by a steel frame structure. The other group was 12 silos set in two rows on a cylindrical skirt resting on 1.2 m thick concrete slabs on pile foundations. The cylindrical skirt is fixed to the pile cap through anchor bolts. The silos were made of 6 mm thick aluminum plate. The silos that buckled were totally full during the earthquake, while those full to only 65% of their capacities did not collapse. During the earthquake, the buckled silos pounded into the adjacent warehouse. The damaged bottom skirts of the silo cones exhibited diamond-buckling modes.
