Preliminary Application of Space-Based Remote Sensing and Geospatial Technology for Investigation on the Geo-Environmental Consequences of Cyclone Aila 2009 in the Bangladesh

Research Article

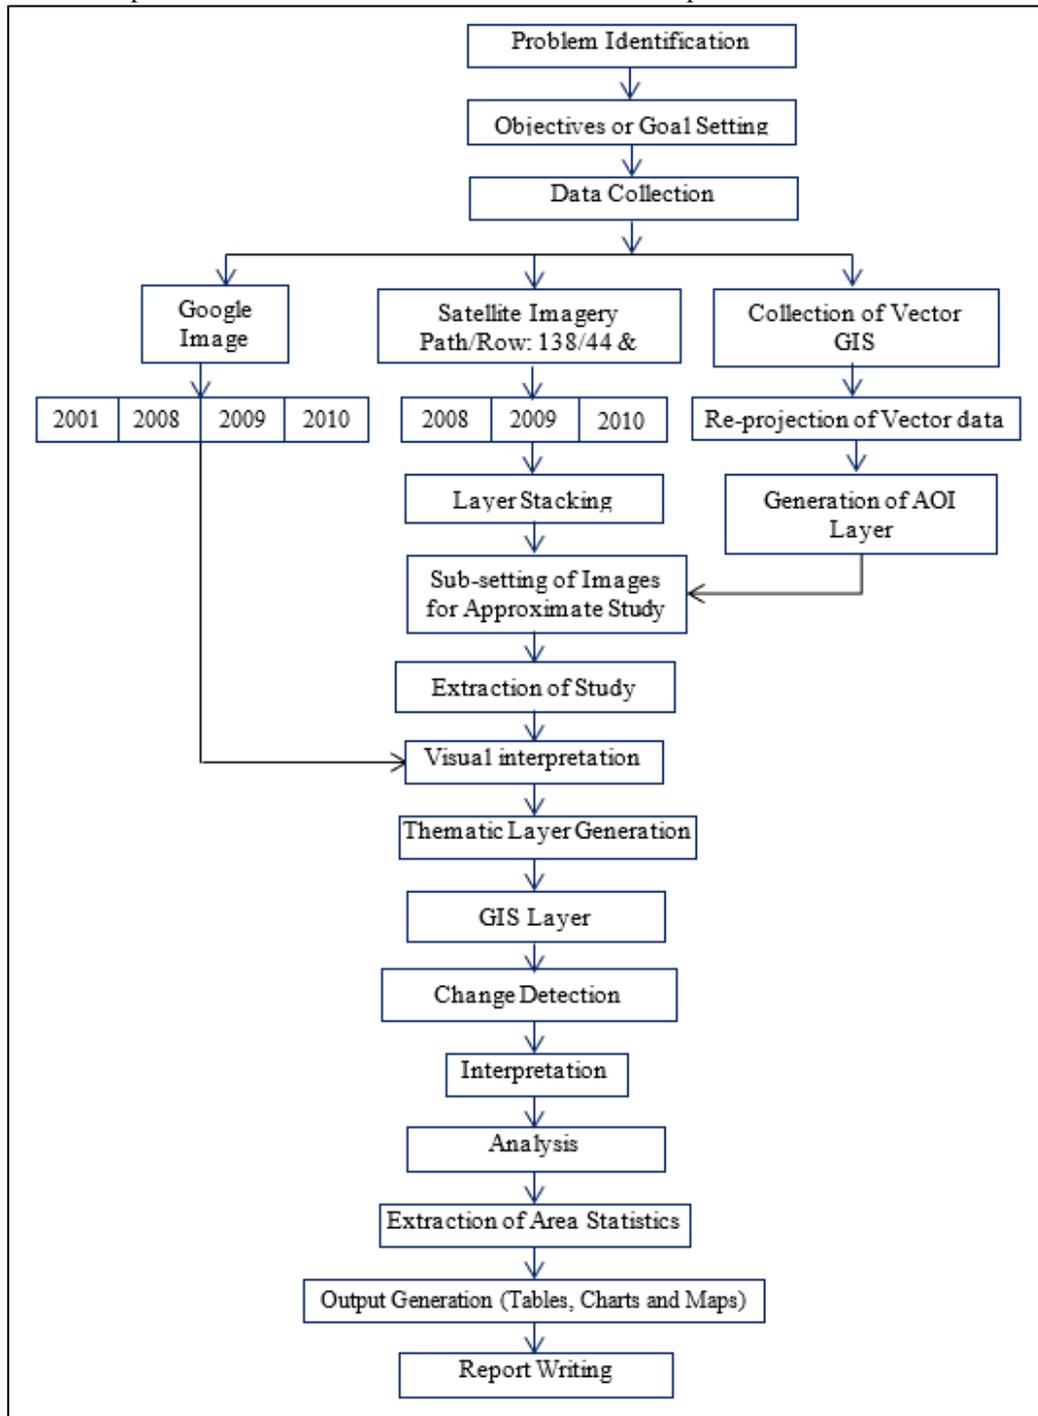
Fig. 2. Flow chart of the working methodology under the present work.

Figure 2 shows the methodological framework as adapted for implementation of the present research study. The study area has been extracted from satellite images by using vector GIS boundary layer. Digital data processing, analysis and interpretation have been carried out to identify the surface features over the area. Thematic data layers were generated following procedural flowchart as mentioned. This research work extensively utilized the ERDAS Imagine and ArcGIS software for various geospatial application under the study theme.

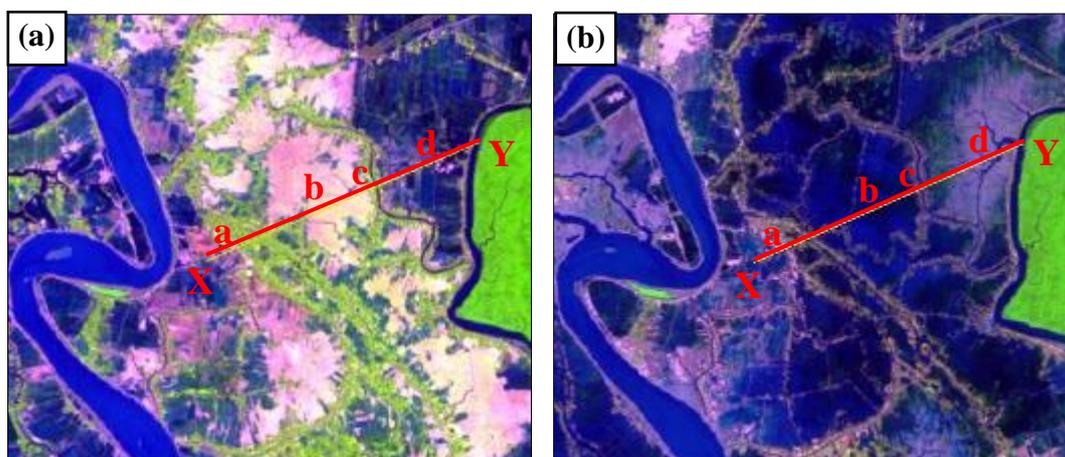
Fig. 3. Images dated (a) February 3, 2009 representing pre-Aila and (b) February 6, 2010 representing post-Aila time sequences respectively in the Koyra Upazila under Khulna district.

Figure 3 shows the Landsat TM spectral images of February 3, 2009 and February 6, 2010 representing (a) pre-Aila and (b) post-Aila situation respectively in the Koyra Upazila under Khulna district. Landsat TM bands 3, 4 and 5 have been loaded in the B, G and R plains respectively of the display device. Spatial profiles have been drawn along a straight line (XY) over the two images. The readily noticeable bluish characteristics of the post-Aila-2009 image as compared to that of pre-Aila-2009-time sequence provide the evinces of storm surge driven water coverage over the area.

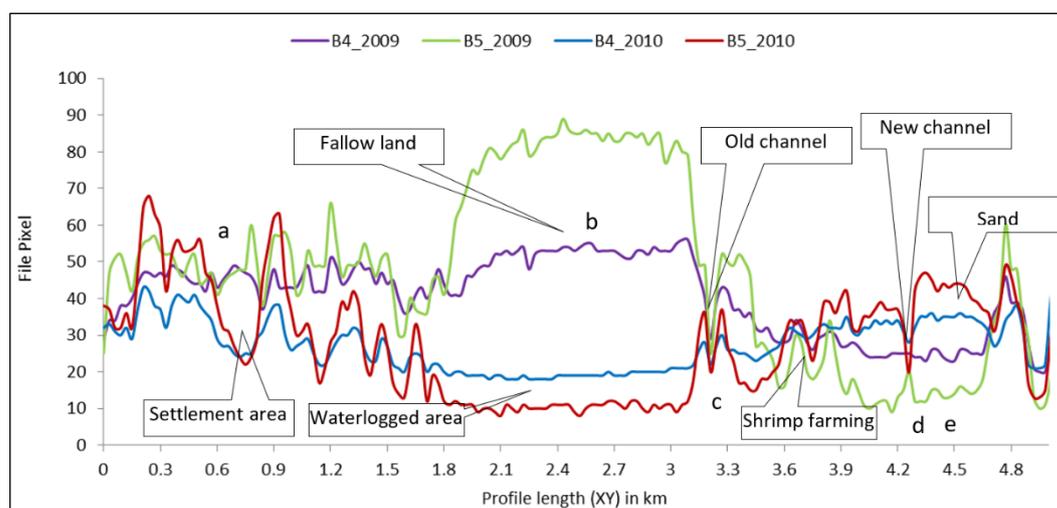
Fig. 4. Linear spatial profiles corresponding to three spectral bands (5, 4, and 3) of Landsat TM spectral color images on the two different dates 3 February, 2009 and 6 February, 2010 representing pre-Aila and post-Aila situation respectively in the Koyra Upazila. The profile line has been shown in Figure 17 starting from position X to position Y and passing through the points a, b, c, and d.

Figure 4 shows the variation of spectral reflectance values in bands 4 and 5 of Landsat TM along a linear profile on two different dates as mentioned. Along the profile a number of specific locations e.g., a, b, c and d has been considered over both the images. Dynamic variation of reflectance values along the profiles on two dates have been interpreted in terms of surface category, its condition and transformation into another category. Profile lines as a function of distance exhibit significant variation of surface radiative intensity over the profiling direction.

Presence of water along the profile line, vegetation and soil radiative properties together determined the intensity of the signal in different spectral bands of Landsat Thematic Mapper (TM) sensor. The optical and architectural properties of vegetation and its density, moisture content of the soil particularly important in relatively low-density vegetation cover collectively determine the overall radiative characteristics of the vegetation canopy system (Rahman et al., 1999). The evolving condition of a landscape with surface components consisting of primary surface classes e.g., soil, vegetation and water is principally dependent on the dynamic changes of surface variables that result in modification in their radiative response properties. In such deterministic processes of surface radiative responses, vegetation phenology, land physiography and condition, amount of incident solar radiation, dynamic soil moisture condition plays important role (S. Rahman, 2007, Rahman 2001). The role of overspreading water has a dual role to play in this regard. Water itself influences the overall canopy radiative characteristics. In addition, presence of salinity in the water affects the vegetation bringing a degradation of vegetation condition with respect to time. In the present work, atmospheric effects in the multi-date satellite images have been removed through application of atmospheric correction procedure with consideration of atmospheric aerosol and molecular scattering. The presence of homestead vegetation as appeared in green color in Figure 3(a) is not visible in the post-cyclone image as in Figure 3(b), though both the images correspond to almost same seasonal time of the year.

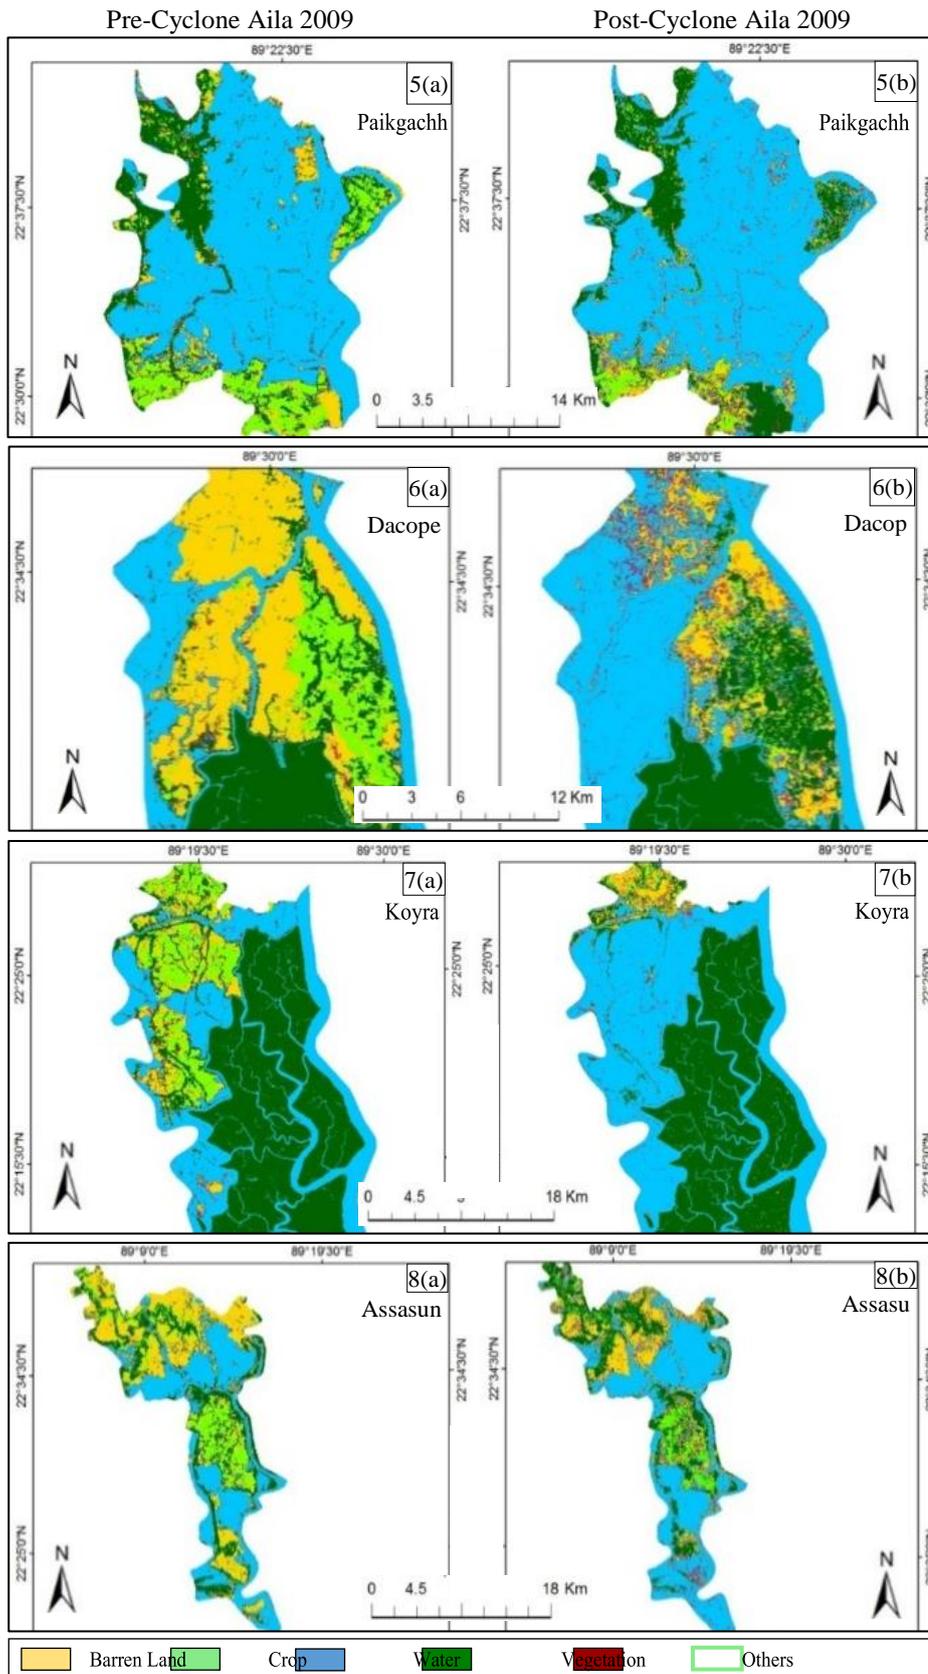
Fig. 5-8. LULC maps for part of (5) Paikgachha; (6) Dacope; (7) Koyra; (8) Assasuni Upazilas. Here ‘a’ and ‘b’ refer to the pre- and post-cyclone condition respectively. All the products have been generated through processing and analysis of Landsat TM images following methodologies as mentioned under the present work.

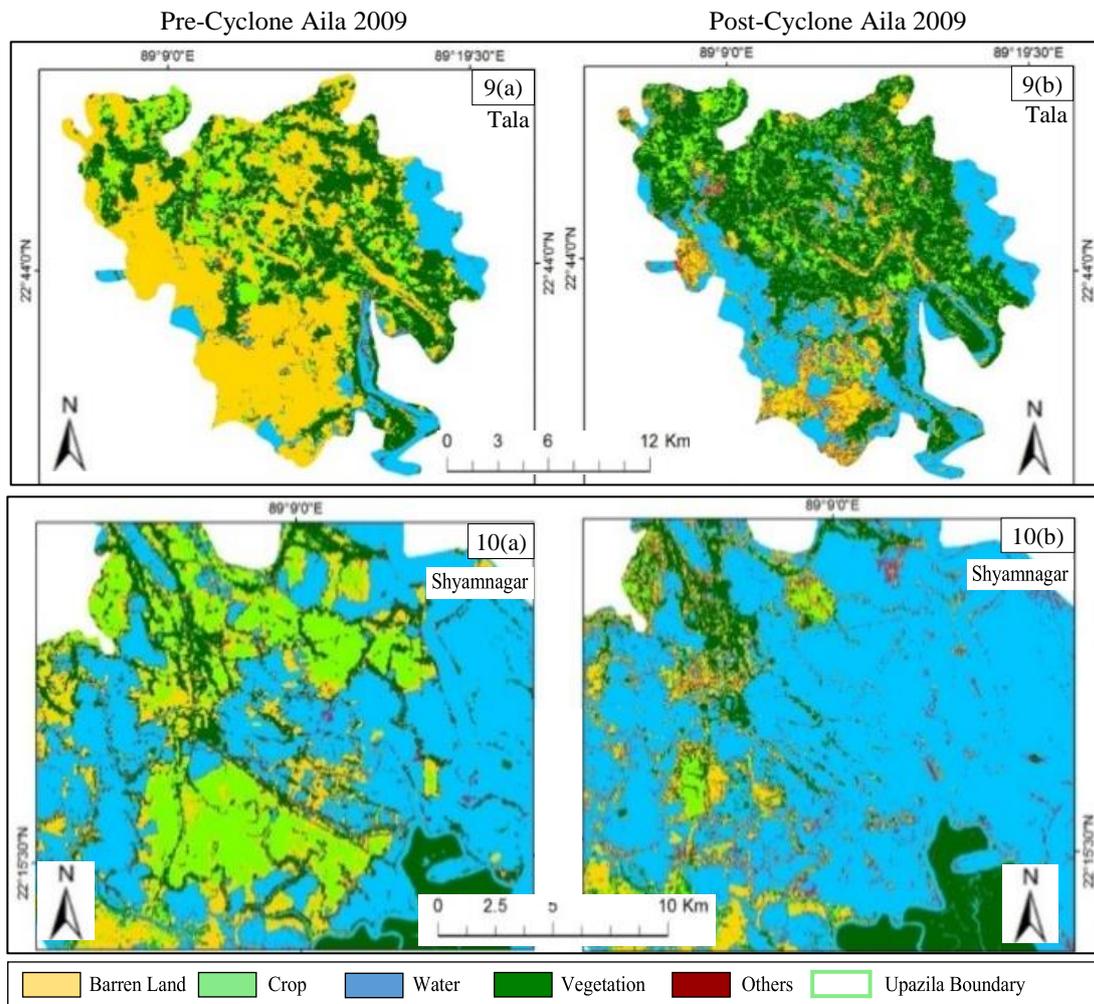
Fig. 9-10. LULC maps for part of (9) Tala and (10) Shyamnagar Upazilas. Here ‘a’ and ‘b’ refer to the pre- and post-cyclone condition respectively.

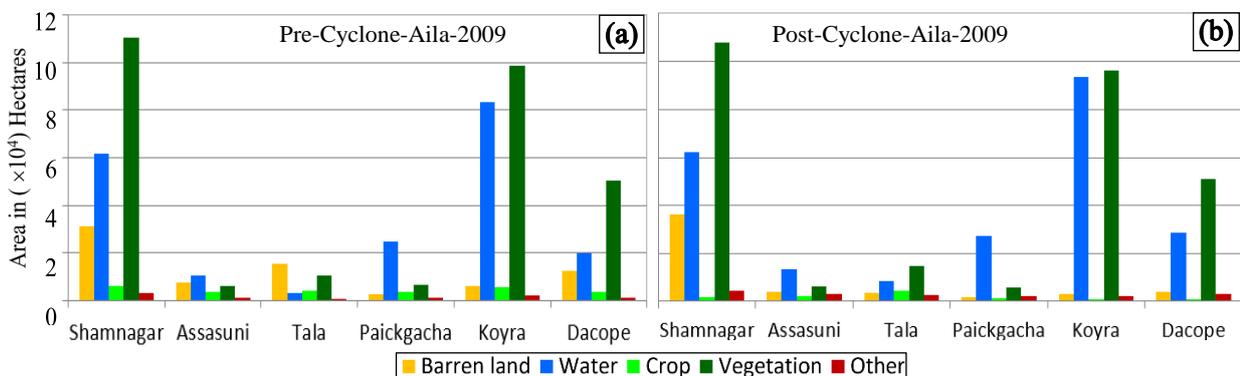
Fig. 11. Landuse/Cover statistics in six different Upazilas of the study area for (a) pre- and (b) post-cyclone Aila-2009. Results have been obtained through processing and analysis of Landsat TM images following methodologies as mentioned earlier under the present work.

The spatial pattern of LULC changes corresponding to various land cover categories in the study area due to cyclone Aila-2009 is shown in Figure 11. Table 3 summarizes the results of analysis of the pre- and post-Aila condition as obtained through classification of Landsat TM image followed by necessary pre-processing. While, Table 4 provides the Change Matrix of water area in the study site after the cyclone Aila-2009. Results reveal that, after cyclone Aila-2009, 3.53% of barren land area has been changed into water area; 1.37% cropland area flooded and 2.06% of vegetation land changed into water area (Table 4). Water bodies increased significantly in spatial extent due to cyclone-driven surge water flooding of various land covers. The water area has been found to be about 36.69% including contributions from all other class categories.

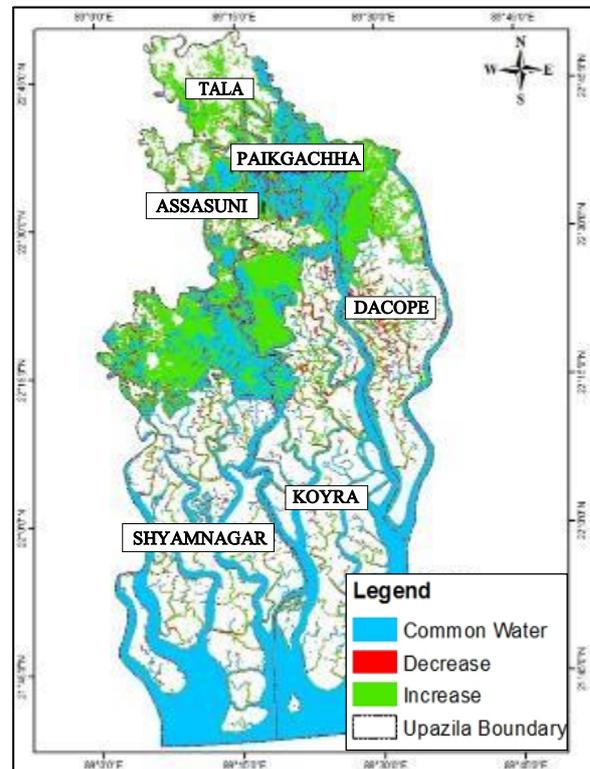
Fig. 12. Landsat satellite derived map of six different Upazilas covering the study area after the cyclone Aila in 2009 representing map of water area increase-decrease.

The spatial distribution pattern of class-to-class area transformation due to cyclone Aila-2009 storm surge for post- cyclone time sequence condition is shown in

Figure 12. While, Figure 13 shows the Landsat satellite derived spatial map of six different Upazilas covering the study area after the cyclone Aila-2009 representing map of area transformation from different class elements

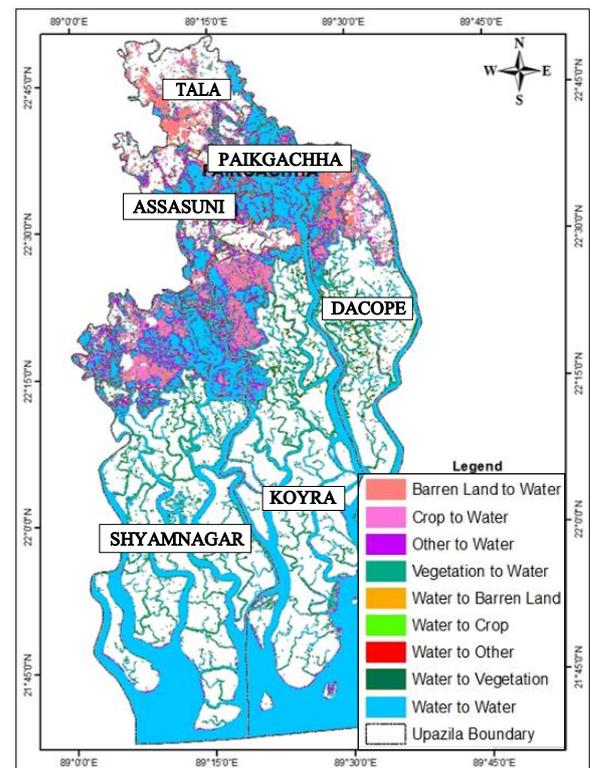
Fig. 13. Landsat satellite derived map of six Upazilas covering the study area after the cyclone Aila in 2009 representing map of water area change due to transformation from different class categories into water class.

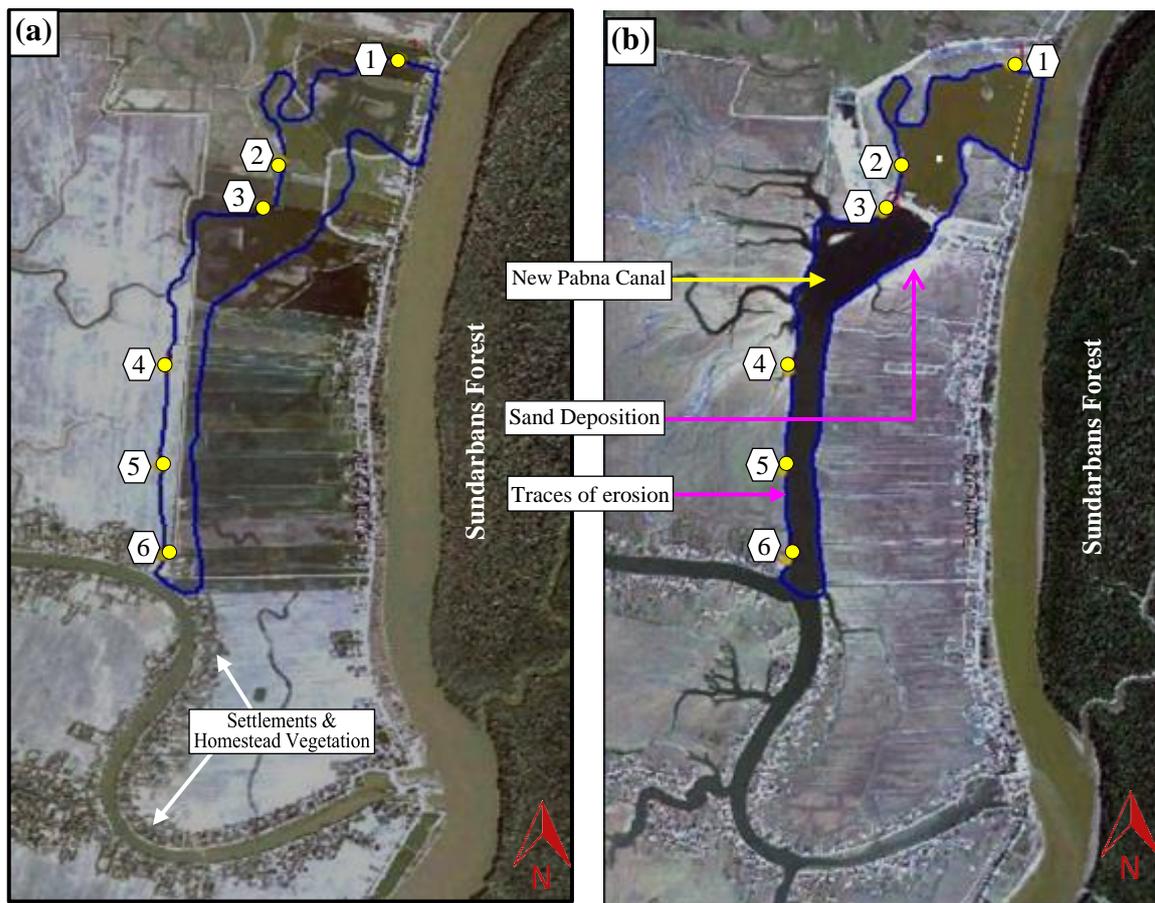
Fig. 14. Image show the (a) pre-Aila 2009 condition and (b) post-Aila 2011 condition.

surface materials. Figures 14a and 14b represent part of Koyra union under Koyra Upazila, Khulna District as observed in Google images of 2009 and 2011 corresponding to pre- and post-cyclone Aila respectively. Comparison of these two figures provides important differences in surface feature configuration over the area. From post-Aila image of 2011 (Figure 14b) existence of a newly created canal (named as Pabna canal) has been noticed. In the pre-Aila image (Figure 14a), the existence of the canal was not evident. The length of this canal has been estimated to be about 2 km and the canal width varies from place to place over a range of about 80 m to about 300 m along the canal direction.

Referring to Figure 14b, it is to be noted that deposition of sand has been observed along the bank of the Pabna canal. After the landfall of the cyclone Aila, inundation over large area has been observed from the upper part of the post Aila image of 2009. Eventually this inundated area forms the newly developed Pabna canal. Erosion occurs along the Sakbaria River and increase River width of about 17 km along its right bank has been noticed.

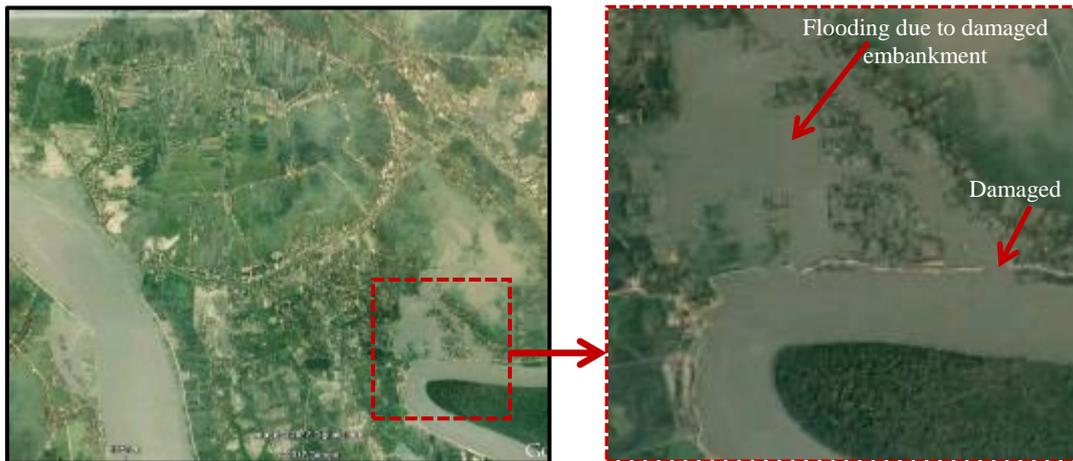
Fig. 15. Color composite image (Worldview, Google) of March 1, 2010 (Post Aila-2009) shows enhanced view (inset) covering a small part of the present study area: Damaged embankment allowing river water to spread up over the nearby land areas.

Figure 15 represents an enhanced view covering a small part of the study area as appeared in the high-resolution color composite Google Earth image showing the river side along with the area around damaged embankment corresponding to March 1, 2010 i.e., same seasonal time but after one year of cyclone Aila-2009. In this high-resolution optical image damages of the embankment are clearly visible. Damaged embankment allowed storm

surge-driven flood water to spread up towards the surrounding areas. Ground data collection at selected location and discussion with the local people therein

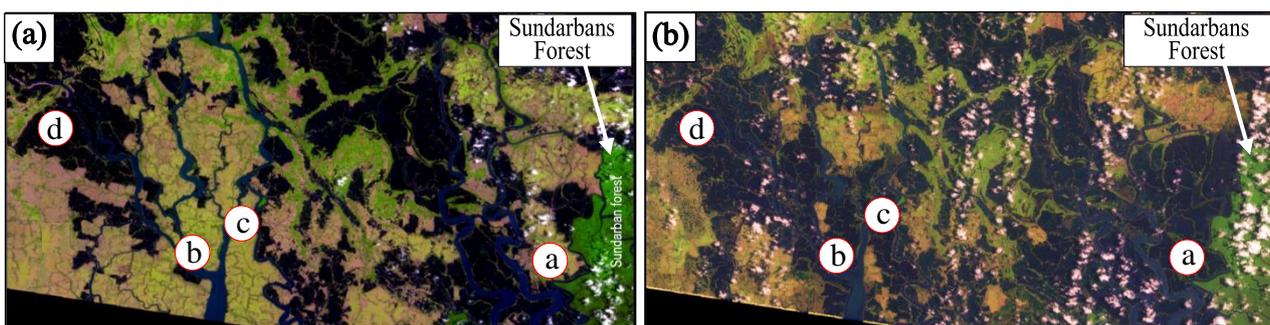
Fig. 16. Landsat TM spectral color composite images RGB (5, 4, 3) of dated (a) May 10, 2009 (Pre Aila) and (b) June 11, 2009 (Post Aila) representing the changes of surface features within the image area.

that becomes worsens for the people of southwest Bangladesh. Bangladesh is a low-lying deltaic country with most of the coastal parts and associated inland of Khulna lie within 1-3 m from sea level. Figures 16a and 16b represent a subset of the affected area as pre- and post-Aila condition as derived through processing and analysis of Landsat TM satellite sensor data. These figures principally demonstrate the water area in part of Koyra and Dacope Upazilas under Khulna district at a date 10th May, 2009, just before the cyclone Aila and 11th June, 2009 immediately after the cyclone.

Comparison of these two images show extended water area under inundation due to cyclone Aila 2009. Comparison of the images show significant increase in water covered areas in the post-cyclone time sequence as compared to that of post-Aila time sequences. Extended spatial coverage of water has been noticed during post-Aila period. Cyclone Aila accompanied by storm surges, flooded the villages and crop fields with saline water from the Bay of Bengal. The incoming seawater caused two-fold effects in the area e.g., (i) water logging in areas at different locations depending on the surface topography and (ii) growing salinity due to incoming surge water had affected most of the vegetation area causing destruction and disappearances of vegetation. A number of scientific studies reported that salinity affects production in crops, pastures and trees by interfering

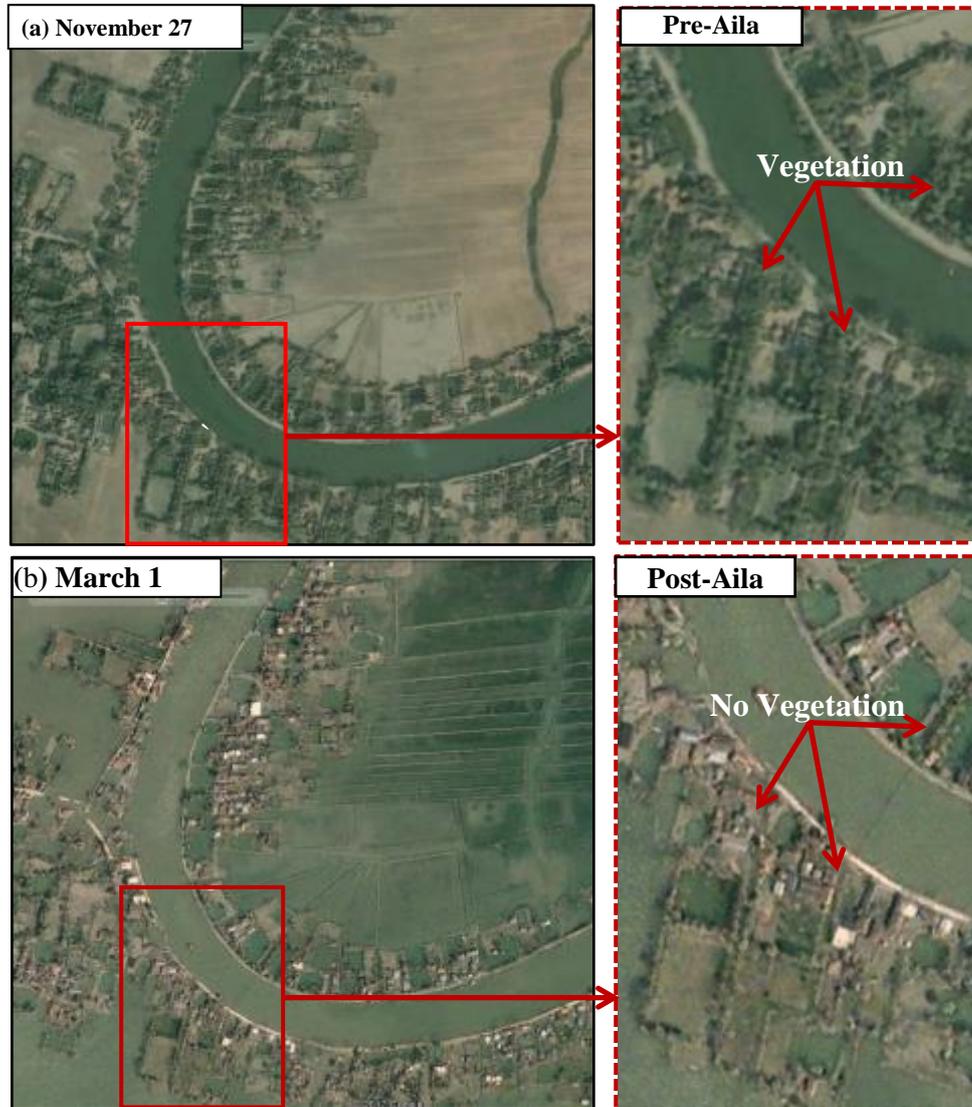
Fig. 17. Images of part of the Koyra Upazila under Khulna district dated (a) November 27, 2008 and (b) March 1, 2010 representing pre-Aila and post-Aila situation respectively.

Figures 17a and 17b exhibit images of (a) November 27, 2008 and (b) March 1, 2010 representing pre-Aila and

post-Aila situation respectively in part of the Koyra Upazila under Khulna district. The presence of water covering the settlement areas is very much visible in image of (b) as compared to that in image (a). The presence of trees and vegetation in Figure 15(a) as textured elements are readily visible over the settlement areas; whereas, such texture is almost absent in Figure 15(b) indicating probable destruction of trees and vegetation.

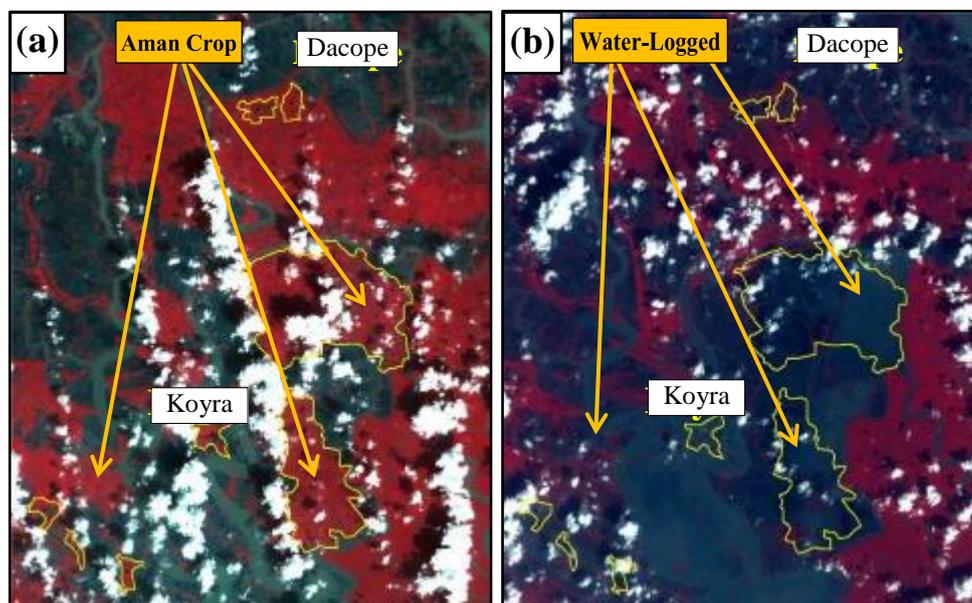
Fig. 18. Landsat TM spectral images (a) October 30, 2008 (Pre Aila) and (b) 17 October 2009 (Post Aila) representing changes of cropping activities and inundation respectively in part of the Koyra and Dacope Upazilas.

Figure 18 represents images dated (a) October 30, 2008 of Pre-Aila and (b) 17 October 2009 of Post-Aila time sequences. Figures represent changes of cropping activities and inundation respectively in the Koyra and Dacope Upazilas under Khulna district due to cyclone Aila. The whitish cluster followed by an adjacent dark shadow generally represents cloud clusters over the Landsat images. The figure demonstrate that relatively large areas were under water in the post-Aila time, which had been previously under Aman crop areas in the pre-Aila image. This area usually shows excess salt content. Such a situation largely limits the crop cultivation in the area.
