RESEARCH ARTICLE

Effect of contamination in cooling water line on emissions and equipment of vessels

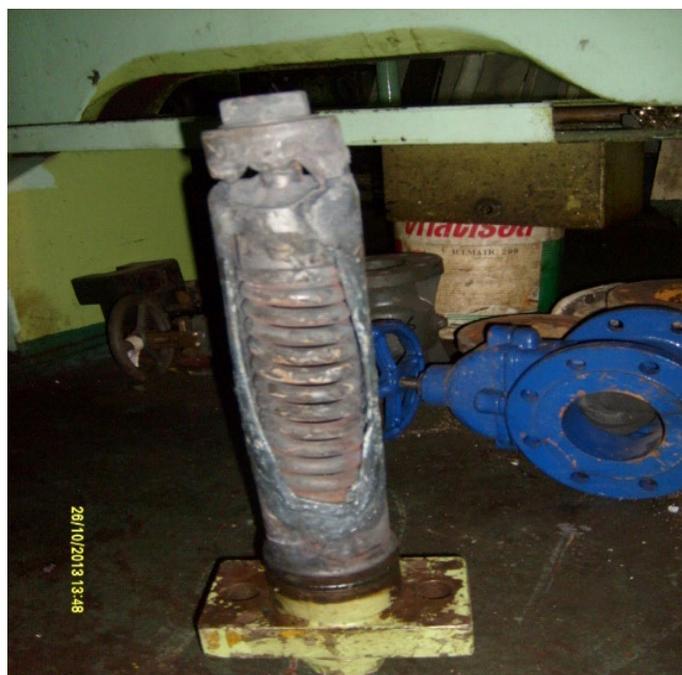
Figure 4. The safety valve of the cylinder number 1

It is known, the safety valve mechanism which runs on the pressure of spring is utilized to provide pressure relief in such cases in order to avoid excessive and dangerous increase of pressure power which occurs in the cylinders during fuel combustion. While the M/V Infinity was going through the Suez Canal on the date of October 26th, 2013, the safety valves of the number 1 and 2 cylinders remained open due to being exposed to contamination for a long period of time and a very serious accident was hardly avoided. While going through the Suez Canal, the safety valve of main engine started to open as soon as the vessel started sailing. At the beginning of the incident, a slight gas leakage was observed at the safety valves between the compression and exhaust periods. The captain continued sailing thinking that they could deal with the problem when they arrived at the anchorage place approximately in two hours' time. One hour later, a considerable amount of increase was noticed at the leakage when the engine revolution decreased by about 22%. On the other hand, as the fuel-oil used had not been separated regularly, that seemed to be a usual condition but the opened safety valve did not close this time. However, we had to go on sailing as we were in the canal. On the other hand, it would be dangerous to sail as the safety valve remained open. The second captain kept on sailing thinking that it would close soon, but as

the revolutions increased, the safety valve started to blow out smoke due to ingenerated flames and as a result of the combustion inside the valve, it started to break into pieces and scatter these glowing metal pieces around. Upon the vessel started sailing by the command of the captain, first pressurized exhaust gases, afterwards flames which ingenerated during combustion began to blow out from the safety valves belonging to the cylinder number 1. Finally, those glowing pieces metals which were broken from the safety valve were scattered around as seen in Figure 4. Thanks to various lucky and narrow escapes, there were not any serious injuries and accidents as a result of having to stop the vessel urgently in the middle of the Suez Canal. The vessel might have gone aground. Fortunately, this incident was avoided by the coil users who were on board by coincidence. They secured the vessels punctually by using the ship's tackles and running rigging. Luckily, there was nobody around the engine during the incident, therefore nobody was injured. And again, while those broken pieces were being scattered, none of them fell on risky areas such as electrical equipment. However, the authorities fined the vessel for 30.000 \$. Additionally, some extra charges had to be paid for those coil users and tugboats. Although contamination seems to be a simple concept at the first sight, consequences of neglecting the contamination proves clearly what a significant issue it is as understood from the incident.

The other major factor that led the valve to remain opened was undoubtedly impurities in the fuel. The fuel was separated only once, then the service tank was directly fueled up. As the

fuel was not clean, it caused the valve jamming. Other reasons for that incident could be heat and pressures generated during combustion and vibrations occurred while sailing.

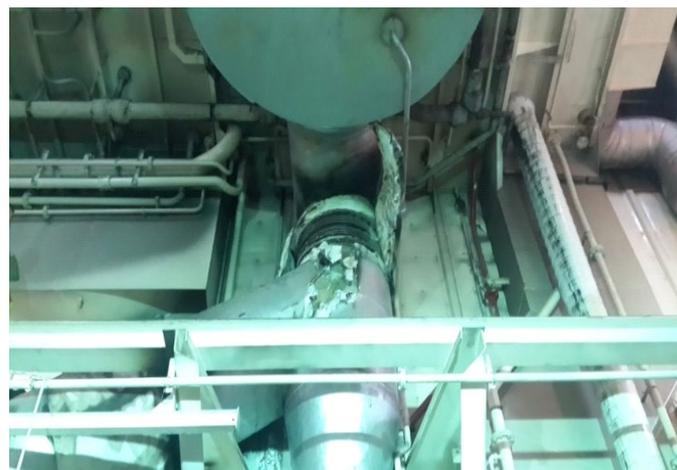
Figure 5. The funnel loop some parts of which fell of and uncovered for repairs

As result of M/V Infinity’s engine operating at critical revolutions for a long time while sailing, some damages such as fractures, dents and collapses occurred on the outer covering of the funnel loop, which caused heat insulation. In Figure 5, the funnel, some parts of which were dented and collapsed due to being exposed to excessive vibration and the funnel loop

uncovered to get repaired are shown. Figure 6 shows some of those pieces of fractures.

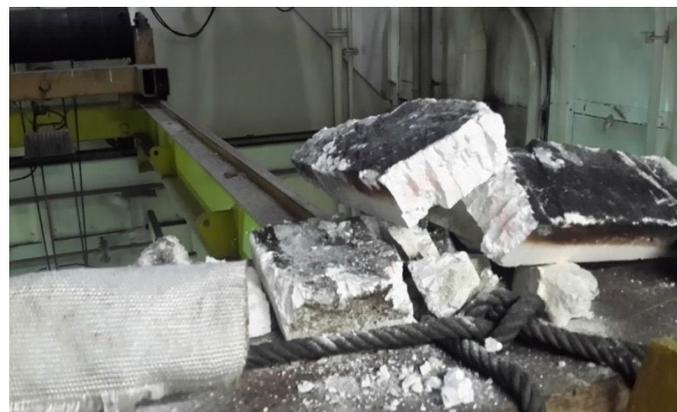
Figure 6. The parts which fell off funnel loop
