AN INVESTIGATION on TRADITIONAL TIMBER-FRAMED BUILDINGS in ÇANKIRI PROVINCE of TURKEY

Neşe DİKMEN (With contributions by Randolph LANGENBACH)

Anahtar Kelimeler: Timber-framed buildings, earthquake, traditional houses, Çankırı

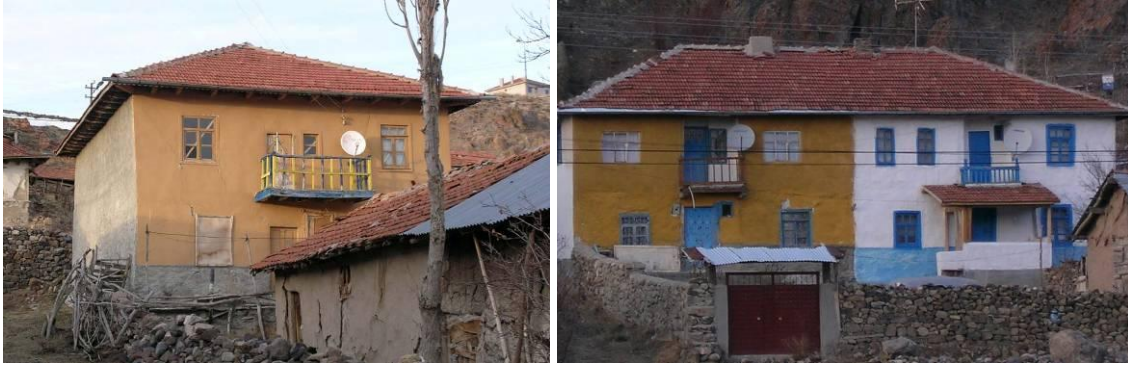
The aim of this study is to record construction systems of traditional timber-framed buildings in Çankırı province of Turkey and also to investigate the opinions and experiences of the inhabitants in the region with regard to their traditional houses and the effects of the 2000 earthquake. Research was undertaken in Çankırı province in 2005. Kalfat Yuva, Kısac, Buğören, Dodurga, Ortabayındır, and Aşağı Kayı Villages of Orta District were visited and traditional buildings were observed. There are two types of traditional construction systems in the region: timber-frame with masonry infill and composite system with unreinforced masonry ground floors and timber-frame with masonry infill second floors. Besides these types, masonry and reinforced concrete structures can also be seen in the villages of Çankırı. The region was visited in 2005 and it was observed that most of the timber-framed structures had little or no damage during the earthquake (Figure 1, 2, and 3).

Figure 1. Timber-framed buildings in Yuva Village

Some masonry barns in the region were heavily damaged due to the earthquake occurred in 2000. However, the damage to timber framed buildings caused by the earthquake was mostly limited to cracking and falling of plaster (Figure 1 and 11) and dislodgement of the masonry infill (Figure 8) in the villages of Çankırı. In general, plaster on the timber elements were cracked and fallen. It can be said that abandoned houses had heavier damages since they

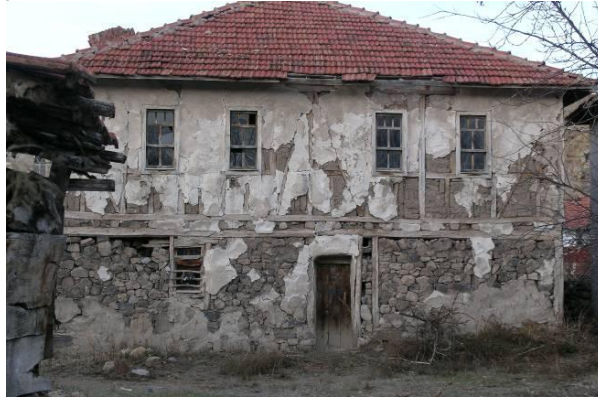
Survey conducted in the villages of Çankırı revealed that traditional construction system is timber frame with masonry infill in this region. In this system, which is called as “*yeğdane*” in the region, infill of the timber-frame is either sun-dried brick or natural stone. For instance, in Yuva Village, nearly all of the timber-frames have sun-dried brick infill, whereas in Ortabayındır Village natural stone infill is commonly used. The reason for that can be the abundance of stone in Ortabayındır village. It was observed that most of the timber-framed buildings in Yuva village had minimal or no damage. The exterior and interior plaster in the houses was cracked and often fallen off due to the earthquake (Figure 6, 7 and 16).

Figure 7. Composite structure: Stone masonry first floor and timber-frame with sun-dried brick infill (Yuva Village).

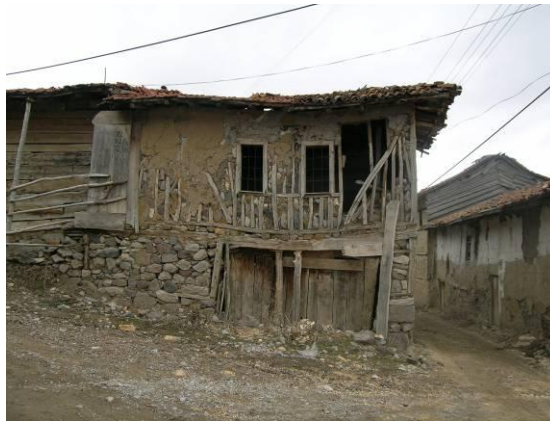
Figure 8. Composite structure: Stone masonry first floor and timber-frame with stone infill (Ortabayındır Village).

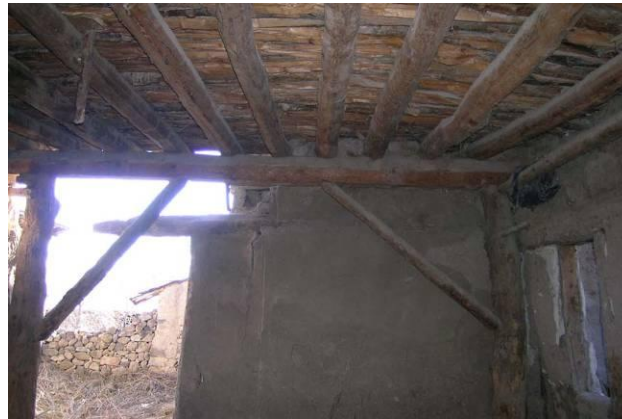
Traditional timber framed systems in this region consist of sole plates, beams, window headers, diagonal members, window sills, girders, door headers, studs, posts, foot plates and infill material (Figure 9). Posts are placed at the corners of the frame on the floor plates and define the basic axis of the building. Studs are secondary posts which are used for dividing the distance between the posts (Er Akan, 2004). Foot plates are used for carrying the studs and posts. Diagonal members strengthen the frame system against lateral forces (Güçhan, 2007). In addition, windows and doors are tied to the structure with the help of window headers, window sills and door headers. Girders are placed on the beams which are located on the posts. A system view of a traditional timber framed house in Yuva village, which had been abandoned before the earthquake, is seen in the Figure 10. Furthermore, Figure 11 presents first floor plan of the building.

Figure 10. Posts, beams and girders (House 1).

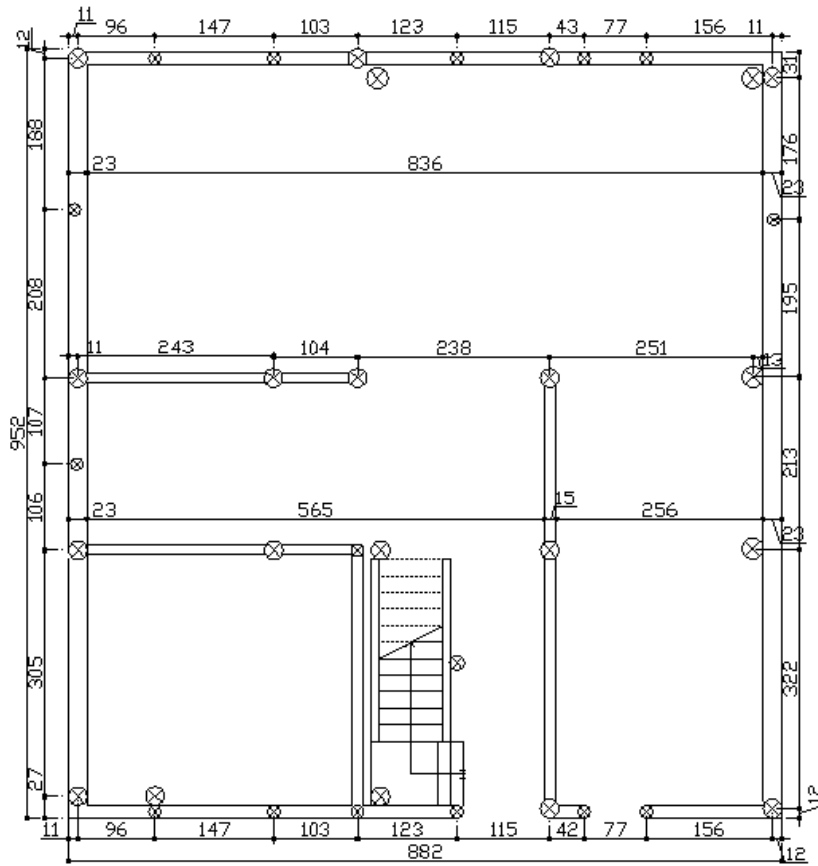
Figure 11. First floor plan of a traditional timber framed building in Yuva village (House 1).
