The 2009 L'Aquila earthquake (Italy): Its characteristics and implications for earthquake science and earthquake engineering

¹Ömer AYDAN, ²Halil KUMSAR, ³Selçuk TOPRAK

1Tokai University, Department of Marine Civil Engineering, Shizuoka, JAPAN ²Pamukkale University, Department of Geological Engineering, Denizli, TURKEY ³Pamukkale University, Department of Civil Engineering, Denizli, TURKEY

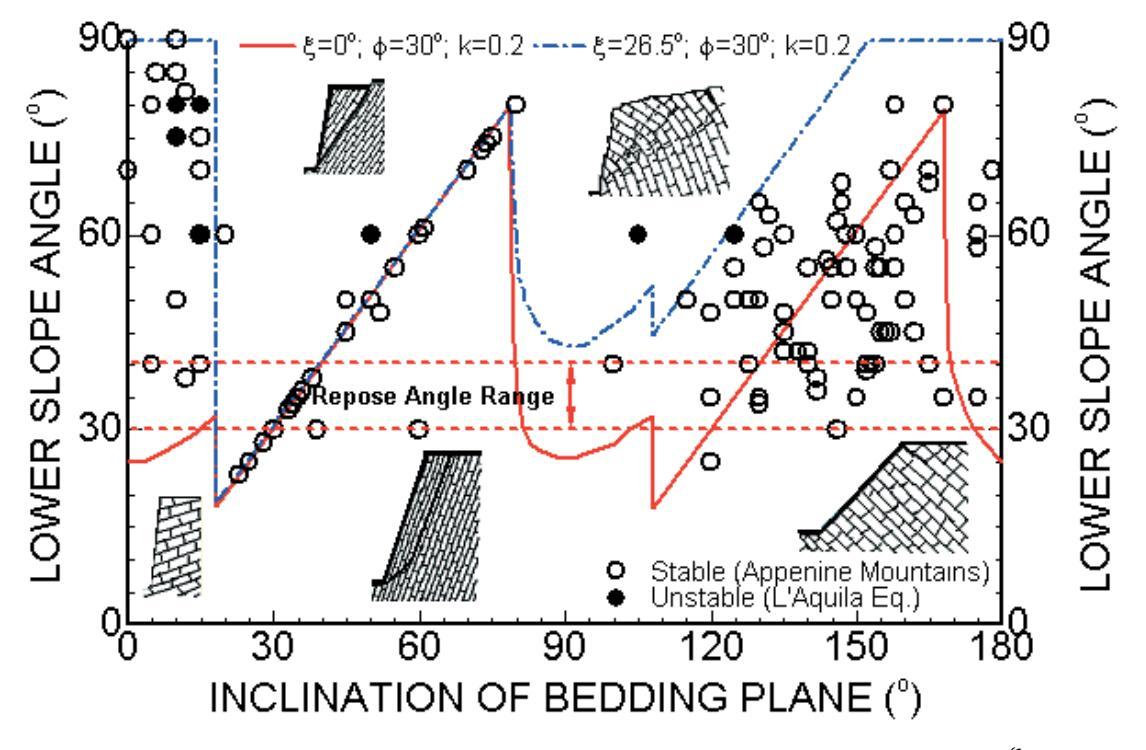
and Kumsar (2009) presented some methods that can be used to analyze the various modes of failure of rock slopes. Figure 14 compares computational results with observational data from stable and unstable slopes. The data compiled by Aydan et al. (1989) from the

Figure 14. Comparison of observational data with computational results prom previous studies (ξ : intermittency angle; *k*: horizontal seismic coefficient; ϕ : friction angle).

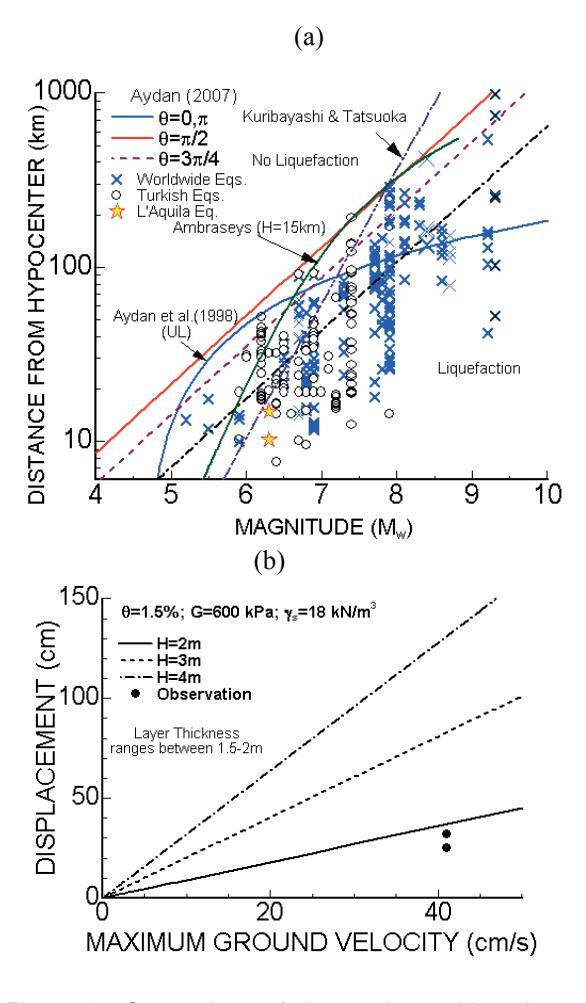
Figure 16a compares the authors' observations with the empirical bounds proposed by several researchers (Aydan et al., 1998; Aydan, 2007; Ambraseys, 1988; Kuribayashi and Tatsuoka, 1979) for the limit of ground liquefaction. The observations are within the limits of liquefiable ground. Since the data is quite limited now, new data may give more accurate results. An attempt was made to obtain data concerning

Figure 16. Comparison of observations with estimations from the method proposed by Aydan et al. (2008) based on maximum ground velocity.
