Turkish Journal of Engineering (TUJE)
Vol. 4, Issue 4, pp. 169-175, October 2020
ISSN 2587-1366, Turkey
DOI: 10.31127/tuje.631481
Research Article

TENSILE AND COMPRESSIVE BEHAVIORS OF THE PULTRUDED GFRP LAMINA

Keywords: Composite Material, Pultruded GFRP, Tensile, Compressive, Damage Analysis

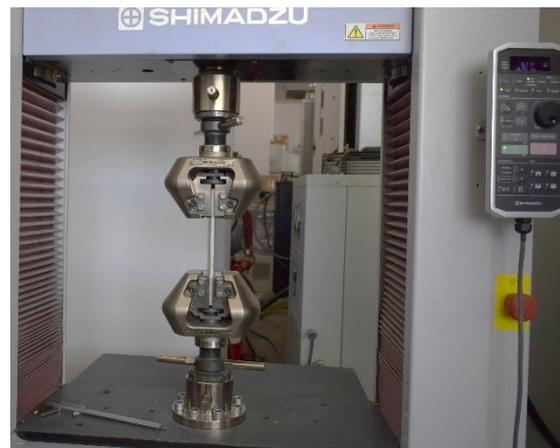
The tensile test was performed according to ASTM D638 (Standard Test Method for Tensile Properties of Plastics). The test was conducted using a Shimadzu universal testing machine with a capacity of 100 kN. The test setup is depicted in Fig. 1. Tensile tests were conducted on the specimens with nominal dimensions of $250 \times 25 \times 6$ mm (length-width-thickness) and $150 \times 25 \times 6$ mm, in order to determine the tensile strength and the displacement in the longitudinal and transverse directions, respectively. The distances between the claws were 190 mm and 90 mm for longitudinal and transverse directions, respectively.

Fig. 1. Tensile test setup

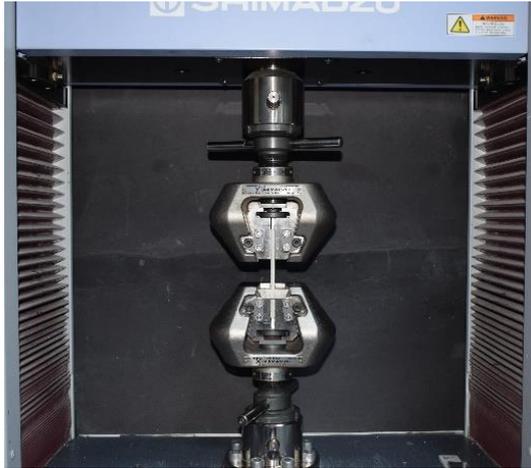
The compressive test is also conducted using Shimadzu universal testing machine and the test was performed according to ASTM D695 (Standard test method for compressive properties of rigid plastics). The test setup is illustrated in Fig. 2.

Fig. 2. Compressive test setup

In this case test speed is 1.5 mm/min. Compressive tests were conducted on the specimens with nominal dimensions of 150×25×6 mm (length-width-thickness) in both the longitudinal direction and the transverse direction, in order to determine the compressive strength and the displacements for both directions.

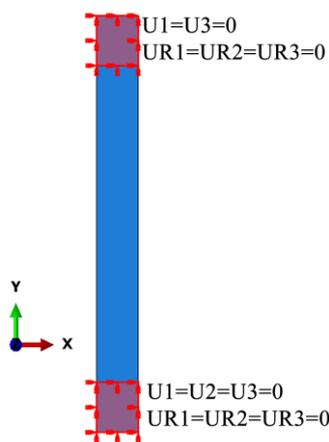
Numerical study was conducted in order to verify experimental results. The commercial software Abaqus was used to model compressive and tensile tests. Shell elements were utilized to mesh the pultruded GFRP. For this purpose S4R general purpose linear 4-sided shell element with reduced integration was used. Elastic properties of the pultruded GFRP was defined using elastic type of “Lamina”. Boundary conditions were defined to the region between the claws to simulate experimental study. The numerical model and boundary conditions are illustrated in Fig. 3.

Fig. 3. The numerical model and boundary conditions

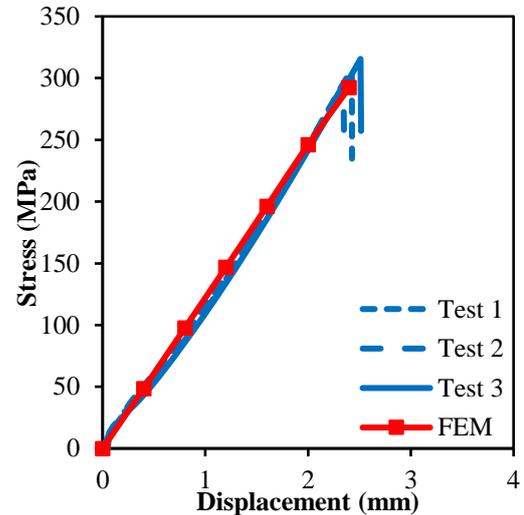
Fig. 4 and Fig. 5 demonstrate the tensile test results of the longitudinal and transverse direction respectively

as well as the numerical results. According to the test results, average modulus of elasticity is approximately 23 GPa and 7 GPa for longitudinal and transverse directions, respectively (Madenci *et. al.* 2020). The test results showed that the tensile strength of longitudinal direction was 7.25 times higher than that of transverse direction. The average tensile strengths of the specimens for the longitudinal and transverse direction are 290 MPa and 40 MPa, respectively. The numerical results are also substantiate to the experimental results.

Fig. 4. The tensile test results of longitudinal direction

When the test results of the specimens (Fig. 4) and the photographs of the damage (Fig. 6) are investigated together, final failure was observed at stress value of 313 MPa and displacement value of 2.5 mm. Matrix crack sounds started to emerge at approximately 280 MPa stress and 2.26 mm displacement as initial damage. Addition to matrix cracks, it was observed that transfer cracks with debonding damage were occurred at the stress and displacement value close to final failure in (0°) fiber layers. As the loading continues, intra-interlaminar cracks occurred in the longitudinal direction and then fiber breakage together with veil damage has started to occur. As a result of fiber breaks in the other layers, final failure has occurred.

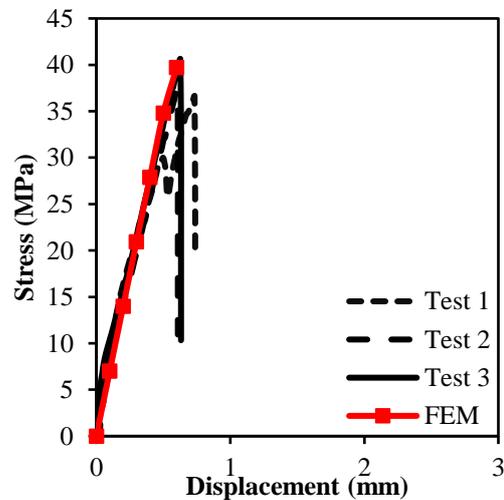
Fig. 5. The tensile test results of transverse direction

When the test results (Fig. 5) and the photographs of the damage (Fig. 7) of the specimens which were exposed to transverse tensile forces, maximum of 40.6 MPa stress and 0.62 mm displacement were observed among three specimens. Fluctuations at stress value of 35 MPa and displacement value of 0.5 mm were observed in the graph due to debonding damage occurring between the fibers perpendicular to the loading direction. Different from other specimens, debonding damage was observed at 29.7 MPa and 0.46 mm in Test 1. Matrix crack sounds were observed at same stress value in other specimens and it has continued to increase up to the resulting damage. While before debonding damage the load was carried together by (90°) fibers and veil surface, after debonding damage the load was carried by only veil surface. Damage to the transverse (90°) layer has progressed due to the damage occurred at randomly generated veil layers. Dense matrix damages were observed at cross section of the specimen as a result of separation of fiber matrix interfaces. The final failure for all three specimens was formed as splitting damage after surfacing veil damage.

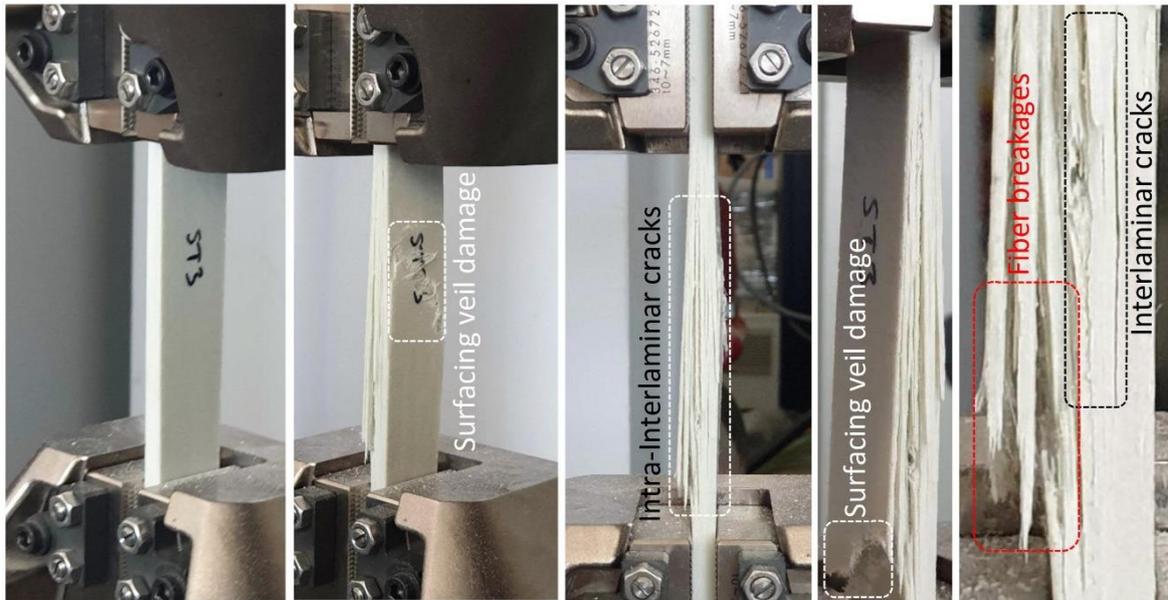
Fig. 6. Tensile test failure in the longitudinal direction

✓ In all tensile tests, it was observed that the damage started with micro-matrix cracks and showed progressive damage in the form of fiber rupture after the formation of delamination in the micro-layer.

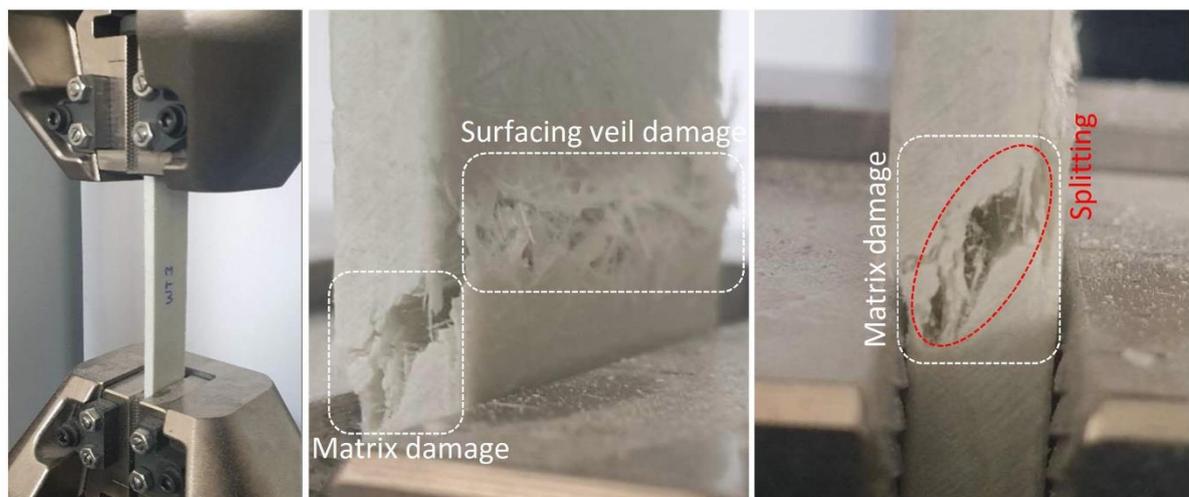
Fig. 7. Tensile test failure in the transverse direction

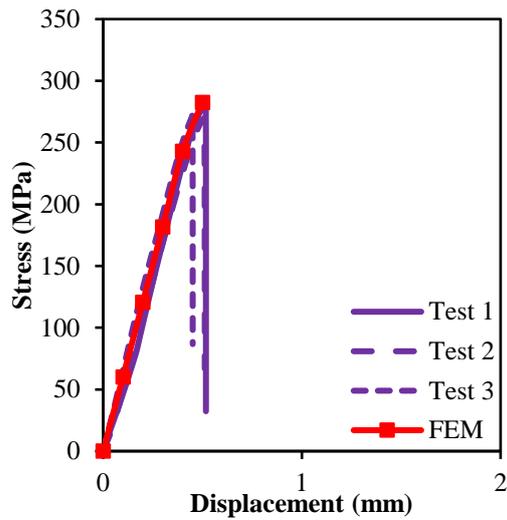
Fig. 8 and Fig. 9 demonstrate the compressive test results of the longitudinal and transverse direction, respectively. Test results revealed that compressive strength of longitudinal direction was much higher than that of transverse direction. Compressive strengths of the specimens for the longitudinal and transverse direction are 280 MPa and 85 MPa, respectively. Moreover, excellent correlation was obtained between numerical and experimental results.

Fig. 8. The compressive test results of longitudinal direction

The test results (Fig. 8) and the photographs of the damage (Fig. 10) of the specimens exposed to longitudinal compressive forces are investigated in detail. Maximum displacement (0.52 mm) and maximum stress (281 MPa) were obtained from Test 1. In compression tests, unlike tensile tests, after a certain stress value (about 250 MPa), deformation due to buckling was observed in the specimen. With the buckling damage, matrix crack sounds started to appear in the specimen.

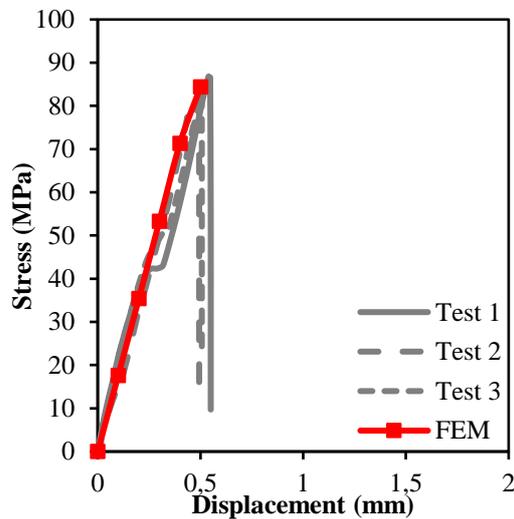
Fig. 9. The compressive test results of transverse direction

The test results (Fig. 9) and the photographs of the damage (Fig. 11) of the specimens which were exposed to transverse compressive forces are given. When Fig. 9 is examined, it is interpreted that debonding damage and matrix cracks occurred due to compression effect in transverse direction fiber layers at 39-53 MPa for Test 1 and 2, and at 76 MPa for Test 2. Despite the formation of debonding and matrix cracks, the veil surfaces surrounding the fiber layers (90°) continued to carry load. When the test graph of Test 1 is examined, it is seen that it represented better damage development during compression and the formation of matrix cracks in the stress value of 83 MPa at veil surfaces caused fluctuations in stress value. With the increase of the applied load, the debonding and matrix crack damages on the specimens were combined and the final failure was formed as splitting at an angle of 45° at 0.55 mm displacement and 86.6 MPa stress value. When the damage photographs given in Fig. 11 are examined closely, it is observed that there is intensive debonding and matrix cracks damages in transverse direction (90°) fibers and fiber breakage damages occur in the veil surfaces due to micro buckling. In all three specimens, the final failure can be interpreted as the damage caused by the transverse direction (90°) fibers which leads to splitting damage in the form of shear planes at an angle.

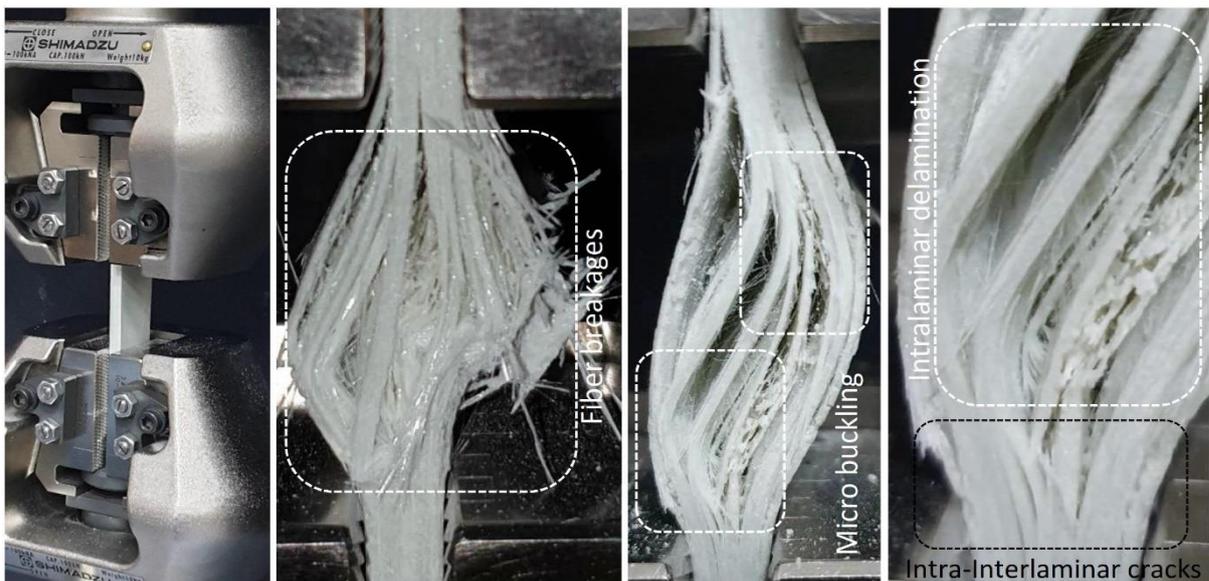
Local delamination damage has started to occur in the fiber direction between the layers and veil surfaces with the increase of intra-interlaminar cracks. At the maximum stress level, delamination damages on the specimen progressed rapidly and the final failure occurred. When the damage photographs are examined, the delamination between the layers and the interlayers formed by the effect of micro buckling on all layers is clearly observed. In the delamination zone, longitudinal direction (0°) fibers showed debonding damage, while fiber breakages were observed in the veil surfaces.

Fig. 10. Compressive failure in the longitudinal direction

✓ In the longitudinal direction specimens, the damage modes that occur after compression and tensile tests are intense; matrix cracks, in-layer delamination, micro-buckling, and fiber break.

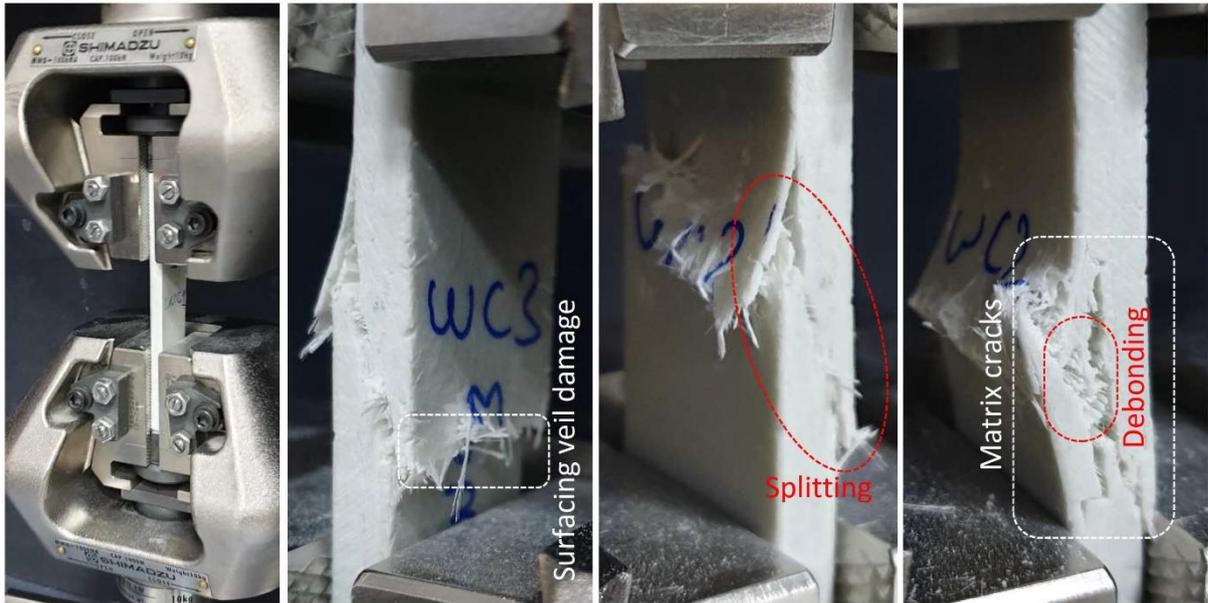
Fig. 11. Compressive test failure in the transverse direction

✓ Damage modes in transverse direction specimens; matrix cracks, debonding, dense matrix damage and splitting damage at 45° angle.
