Disaster Preparedness of Çankırı Museum Building (Turkey) Converted from a Historical Building

Abstract

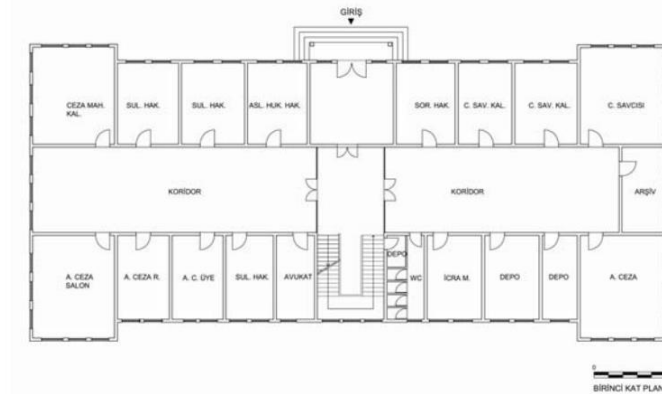
Figure 4. Previous plan scheme of Courthouse (Topçubaşı, 2009).

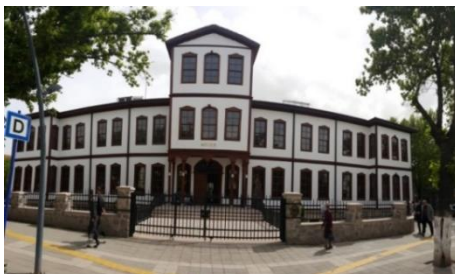
Figure 5. Çankırı Museum building (General Directorate for Cultural Heritage and Museums, 2021).

- Structural features: Çankırı Museum consists of a basement, two floors starting from the ground level and an attic (Figure 5). The basement is made of rubble stone walls, with cut stone in the corners. The ground floor is made of the timber framed system and mudbrick infill. The first floor consists of timber frame with *baghdadi*. It is understood that the architectural system of the building gets lighter while reaching the upper floors in the building. The building materials in the outer walls are solid blend bricks between the timber frame.

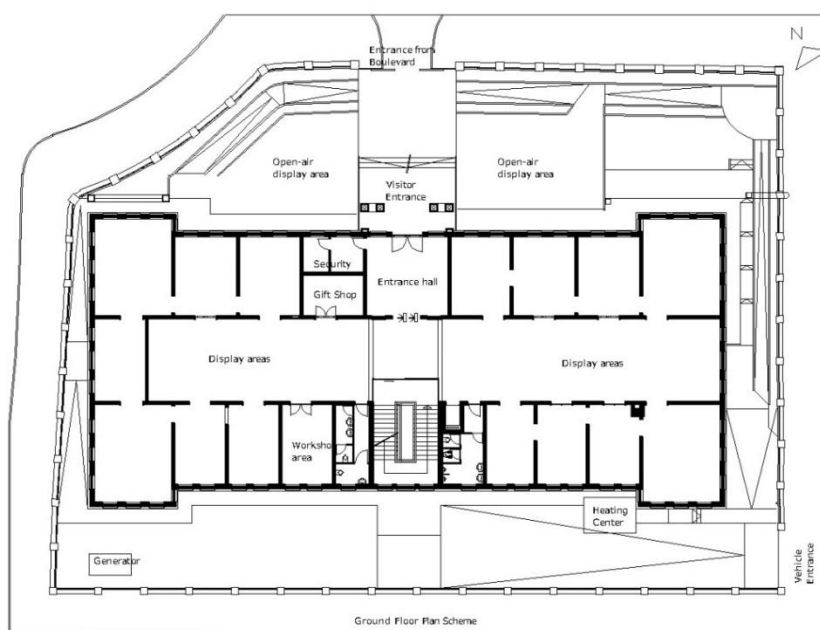
Figure 6. Current plan scheme of the museum⁵

- Spatial features: The building has a rectangular symmetrical plan with four protrusions on the corners of the building and a *sofa* called corridor (Figure 6). The building entrance reached by a three-step staircases is a monumental wooden pillared entrance in the middle of the north facade. There is also a bay window above the entrance to highlight.

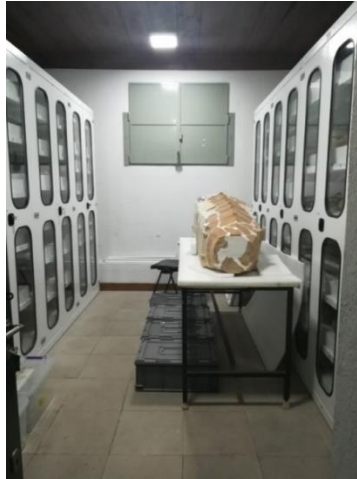
Figure 10. Artifact Storage Space (Ankara Directorate for Surveying and Monuments, 2021).

2. Artifact storage spaces: There are storage spaces, divided according to the types of the artifacts: archaeological artifacts, ethnographic artifacts and fossils, spread over an area of 600 square meter along the corridor of 5.80m wide, on the basement floor (Figure 10). The entrance of storages is on the basement floor in the middle of the south facade of the building (-3.00m. elevation). There are also artifacts acceptance and quarantine rooms used in the process of bringing artifacts to the museum building. On the basement floor, there is also another space used for taking photographs of artifacts and conducting preparations for exhibitions and transportation of artifacts (packaging, labeling).

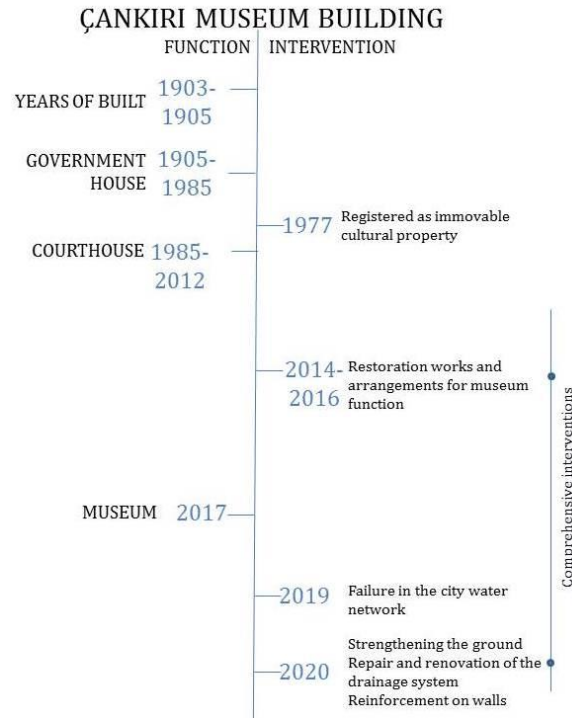
Figure 11. Demonstration of Functions and Interventions for Çankırı Museum

Interventions were made at different times within the scope of using the Çankırı Museum building for different purposes (Figure 11). The building has undergone restoration that included works

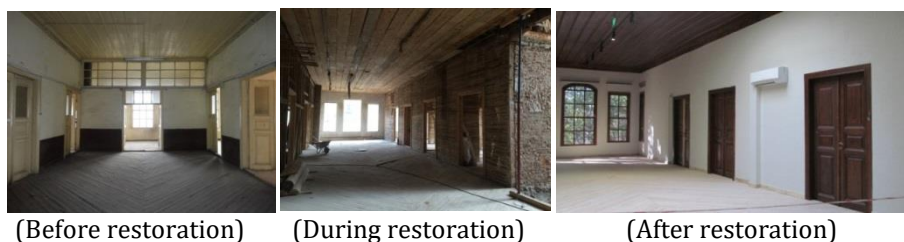
Figure 13. Restoration works (General Directorate for Cultural Heritage and Museums, 2021).

During the restoration work, it was understood that the load-bearing walls on the basement floors were intact, but there were decays in the timber framed system and also the infill material had lost its properties, which became evident after the plaster rasping made on the ground and the

first floors (Figure 13). Meanwhile, heat insulation was used instead of any other infill in between the timber framed system. The building materials in the outer walls have not been changed.

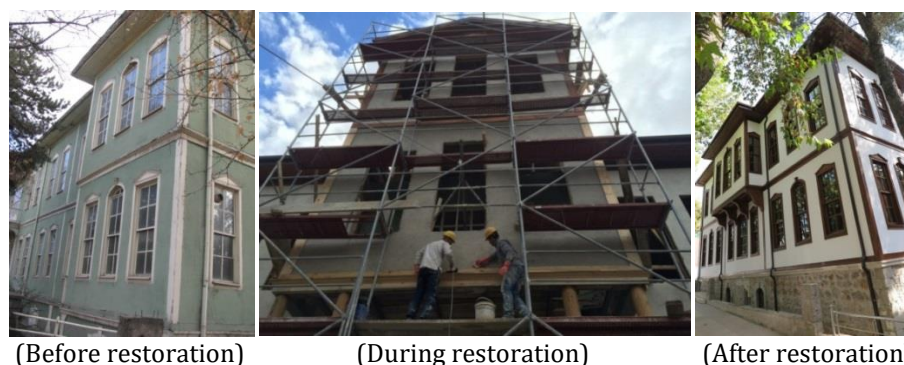
Figure 14. Restoration works (Ankara Directorate for Surveying and Monuments, 2021).

At the same time, the bay window on the north facade was rebuilt on metal bearing beams and foundations due to decay in the wood material. After the structural strengthening of the building, a new drainage system was built around the building. Since there were decays in the wooden material, the roof has been renewed in its original form with hard and durable wood. During the restoration process, wooden doors and ceilings were preserved; maintenance was done and repairs were made (Figure 14). The rasping was applied on the walls in the interior spaces. In the exhibition spaces, the windows were closed in order to avoid the damage of daylight to the artifacts. The reinforced concrete staircase was covered with wooden steps to make it compatible with original form. The cracks in the stone walls were repaired using lime-based mortar.

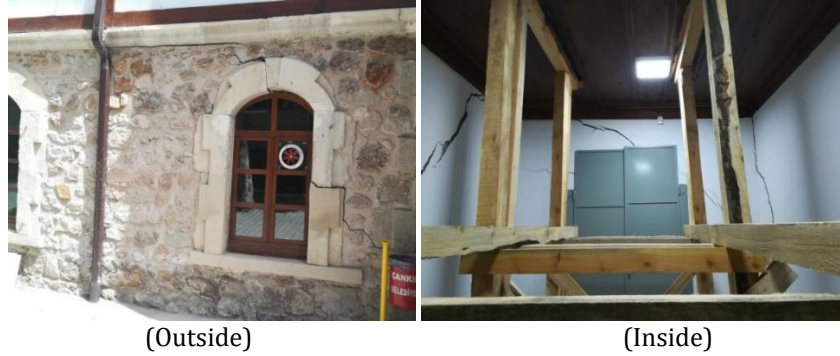
Figure 15. Cracks seen on the walls in 2019 (Ankara Directorate for Surveying and Monuments, 2021).

Disaster preparedness will be evaluated in terms of the disasters of earthquake, fire, flood, landslide for Çankırı Museum. There are methods used in earthquake risk management such as determining the tolerable degree, identification of the hazard, approximation of the earth movement and possible responses of the site, building and the artifacts. Interdisciplinary work by seismologists, architects, structural engineers, geologists, conservators, designers and occupational safety specialists is necessary for earthquake assessments. Considering the earthquake and landslide risks arising from the location of the Çankırı Museum, the types of soil, being in the landslide area, earthquake zone and seismic movement were investigated as the reasons of hazard. It is reported on the ground reinforcement report (May 2019) that the Çankırı city center is on the 2nd level according to earth movements; there is no harm in terms of liquefaction and mass movements problem for the area. It is not a landslide area, either. Because of the environmental problem caused by ground water in 2019, ground reinforcement projects have been implemented. Meanwhile the artifacts were stored in the former museum building until the ground reinforcement was completed. The museum was closed to visitors in 2019, due to deformations which resulted in deep cracks up to 5 cm. on the load bearing walls caused by the land subsidence (approximately 10 cm.) in the south of the museum building (Figure 15). By

acoustic leak detection, the reason for the collapse of the foundation in the building was determined as a water leakage from a city network to the foundation. Firstly, drilling works were carried out at the basement in 2019 and a ground reinforcement report was prepared in May 2019. Examination holes were also excavated in order to obtain information about the foundation of the building (Ankara Directorate for Surveying and Monuments, 2021).

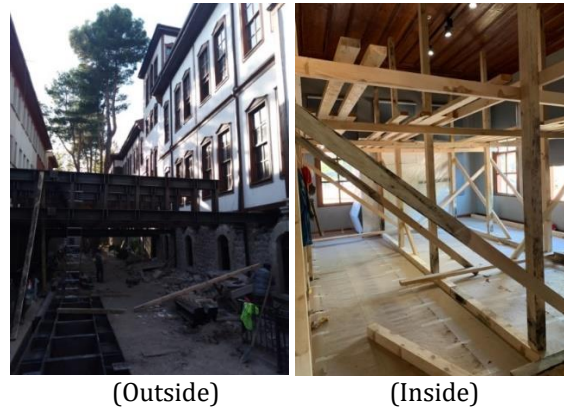
Figure 16. Scaffolding (Ankara Directorate for Surveying and Monuments, 2021).

Before the reinforcement process, the building was suspended from the outside and inside to prevent a possible partial collapse in the eastern wall and its effects on the whole structure. Steel I-beams were used as scaffolding between the museum and the neighboring building outside; and wooden beams were used inside in order to provide stability while restoration (Figure 16).

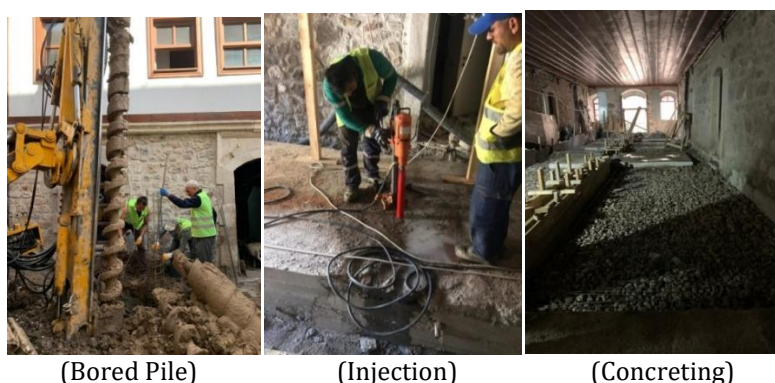
Figure 17. Ground reinforcement in 2020 (Ankara Directorate for Surveying and Monuments, 2021).

Within the scope of the ground reinforcement works carried out in 2020, cement injection was made into the ground; reinforced concrete bored piles were applied; and crushed stone and poor concrete was laid on the ground. Subsequently, reinforced concrete support beams were built on the foundation. (Figure 17) (Ankara Directorate for Surveying and Monuments, 2021). It is recommended that as a precaution against earthquake, ground seismic base insulator applications (Canadian Conservation Institute, 2015), which are newly seen in world, could be used in historical building reconstruction projects and implementations more often.
